Heritage Impact Assessment

No 7 Father Mathew Quay

Cork City Record of Protected Structures – PS085

Report By: Robin Turk & Daniel Noonan

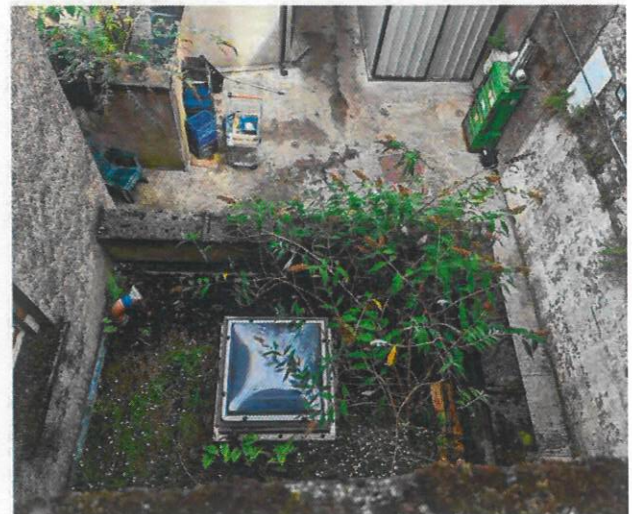
Roof of single storey flat roof addition at rear.

- Demolition action 1:** Demolition of flat roof to single storey addition at rear.
- Reason: To return this to its former use as an enclosed yard space

- Impact: Physical - minimal
- Mitigation: Care should be taken to protect the walls around the removed roof particularly in terms of the north wall of the main house which may need some consideration for its structural support once the roof is removed. Demolition should be confined absolute minimum to achieve the required action. The work should be scheduled under the guidance and supervision of a supervising architect and attending conservation specialists; with appropriate records created and maintained.

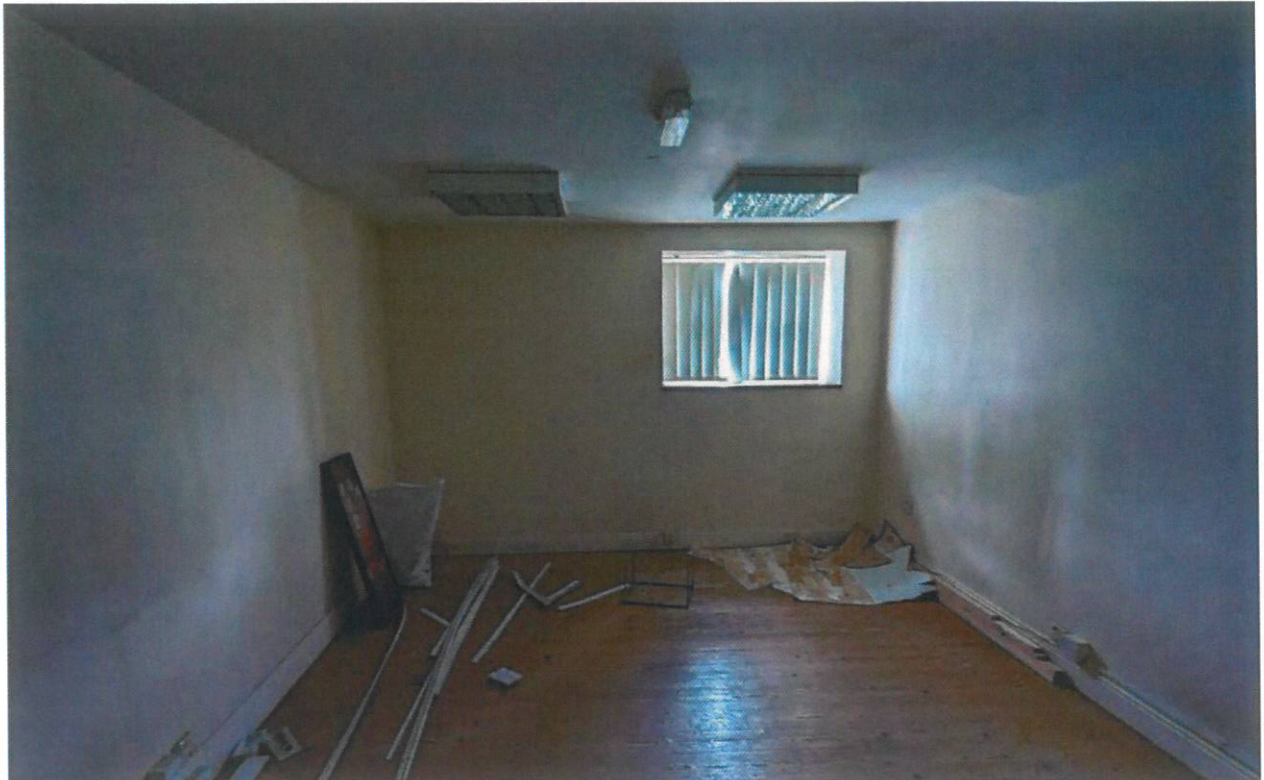
Room G01 looking south.

- Demolition action 3:** Demolition of corner feature of unknown character is G01.
- Reason: To improve visual clarity and remove modern accretion.
- Impact: To be confirmed see below.

- Mitigation: Existing plasterboard lining in this area should be carefully removed in advance of works to investigate if any historic features survive in this corner. If features of note do survive the proposed works in this area should be reviewed in consultation with the conservation officer. Care should be taken to minimise impact on surrounding fabric at all times.

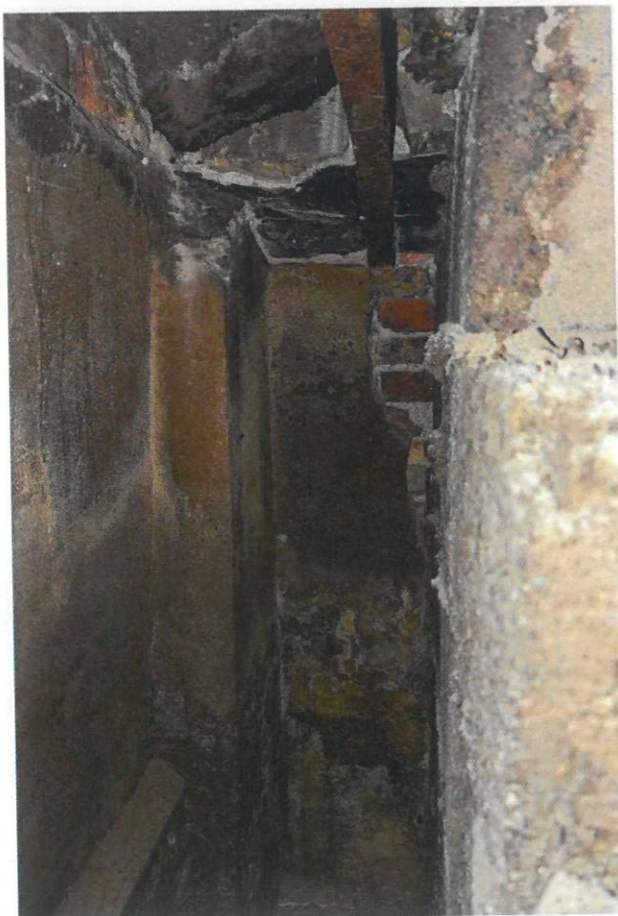
Interior of boarded up fireplace in G04.

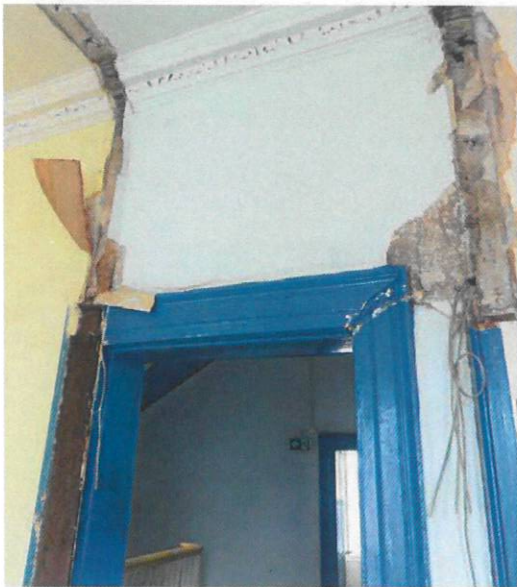
Door architrave and partition scars in S01.

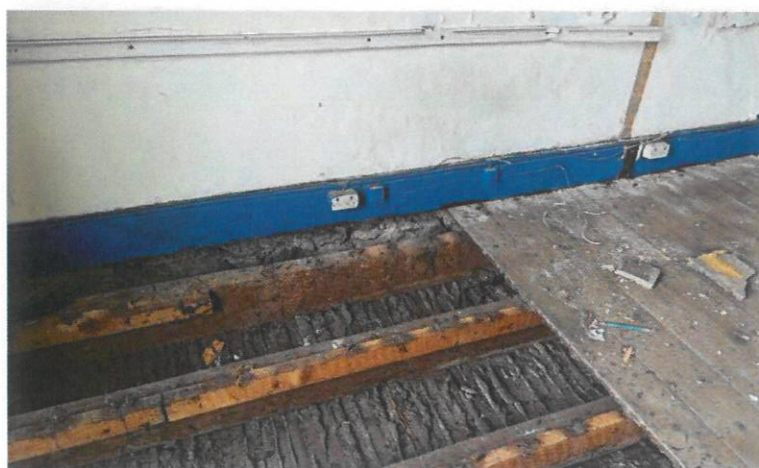
Partially Removed floor in S04.

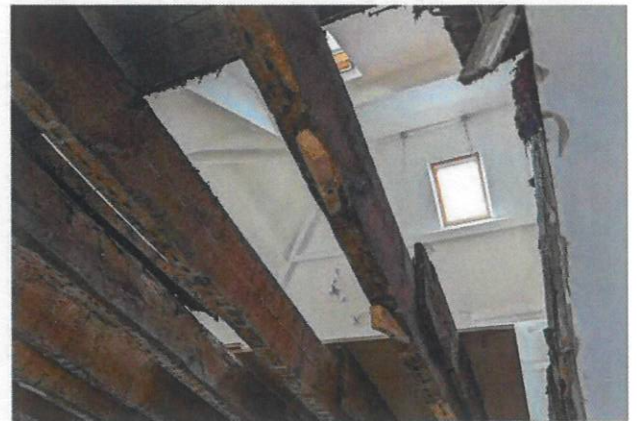
Room T03 ceiling timbers in eastern part of room.

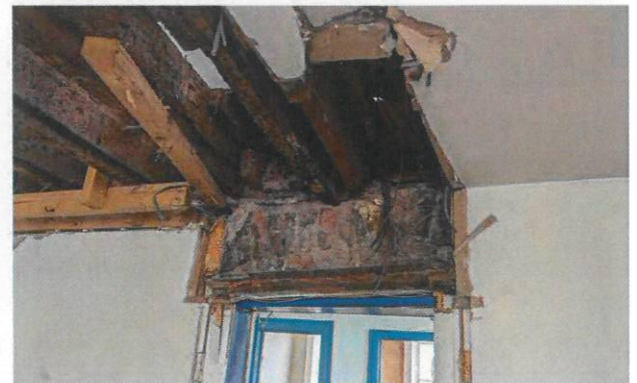
Door to T03 showing damage from partitions.
