Heritage Impact Assessment

No 7 Father Mathew Quay

Cork City Record of Protected Structures – PS085

Report By: Robin Turk & Daniel Noonan

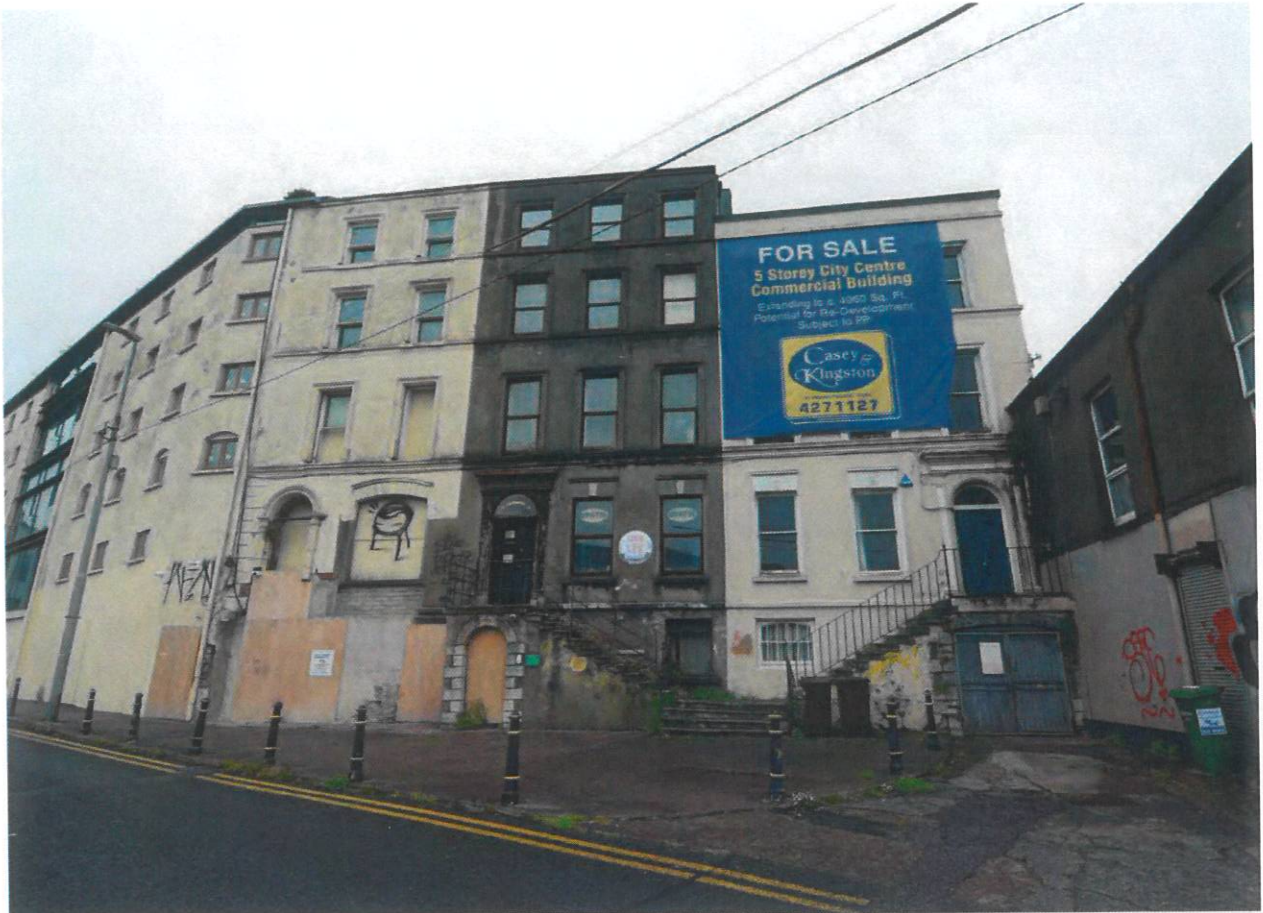
Front (south) elevation showing neighbouring properties.

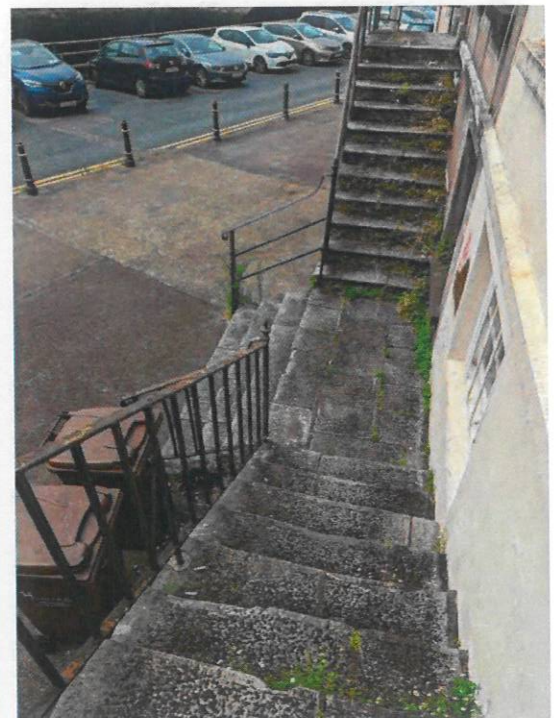
Steps and railings to south elevation.

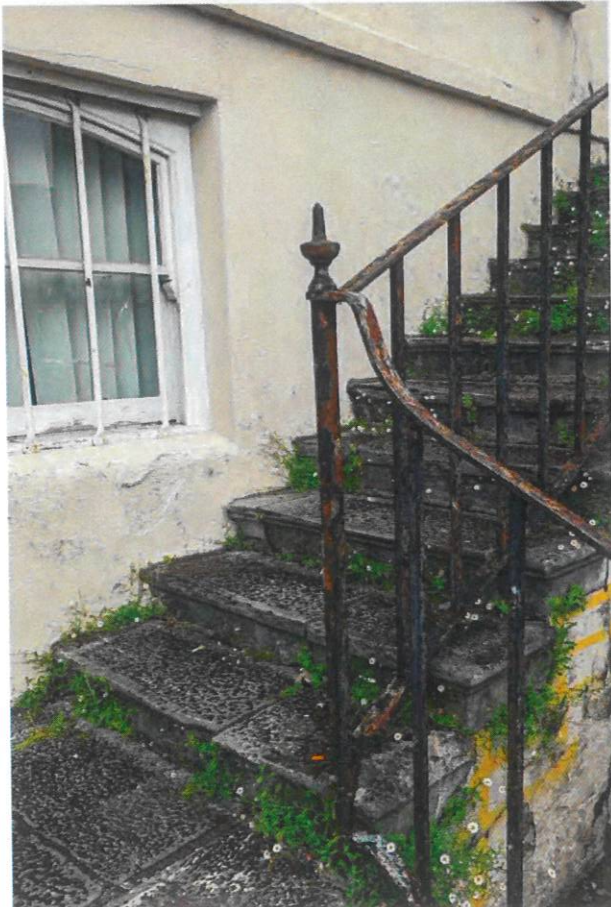
Detail of railing and limestone steps to front.

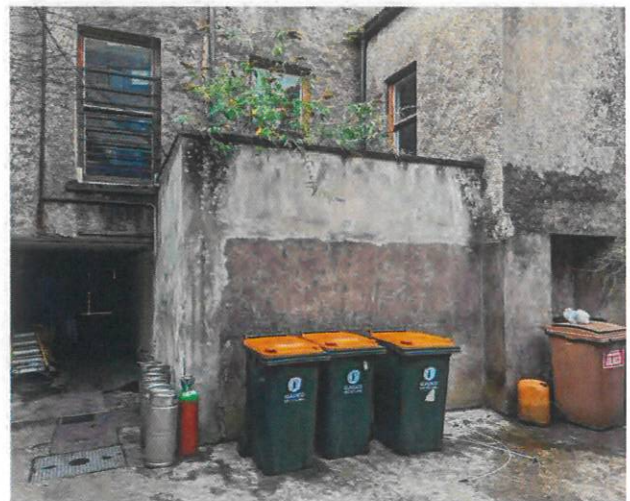
Rear yard showing passageway and one and two storey additions (middle and right).

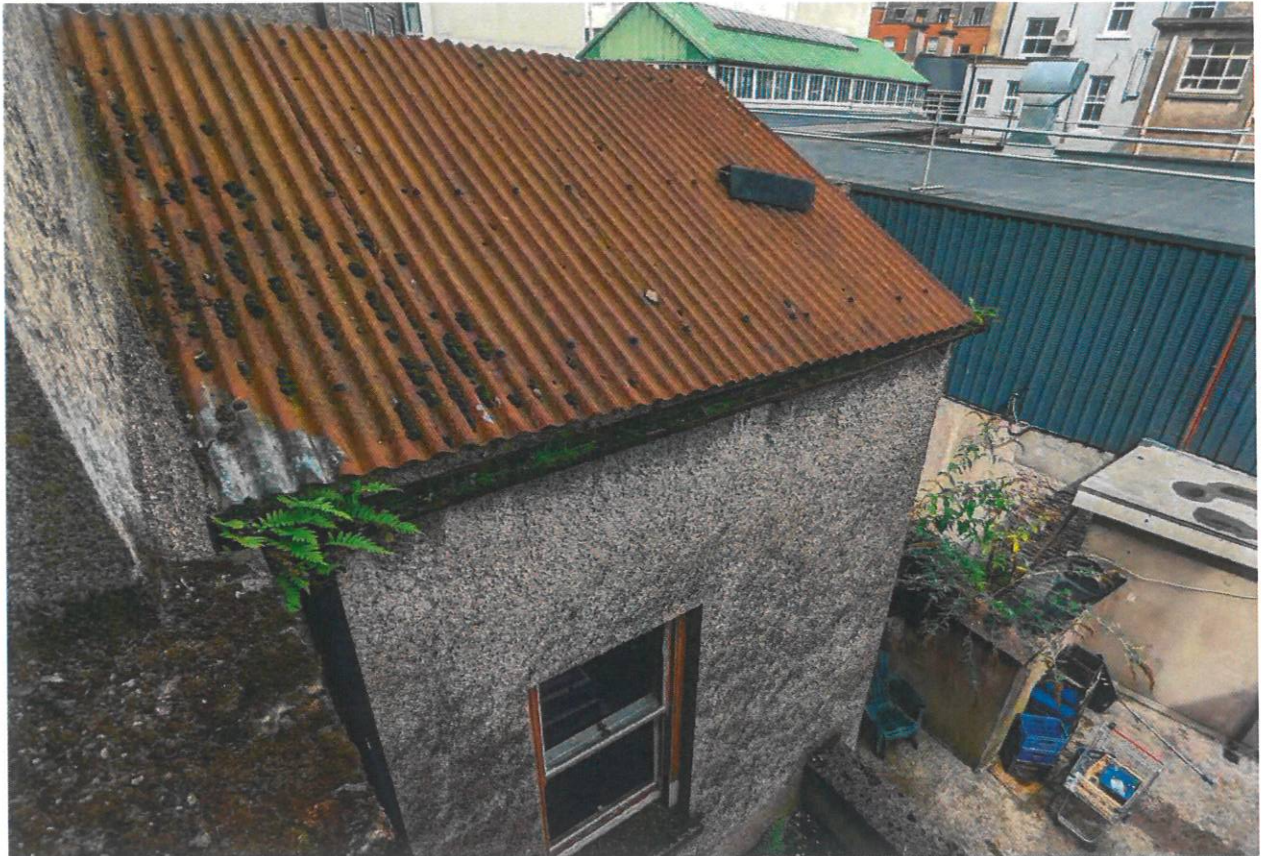
Roof of two storey addition at rear.

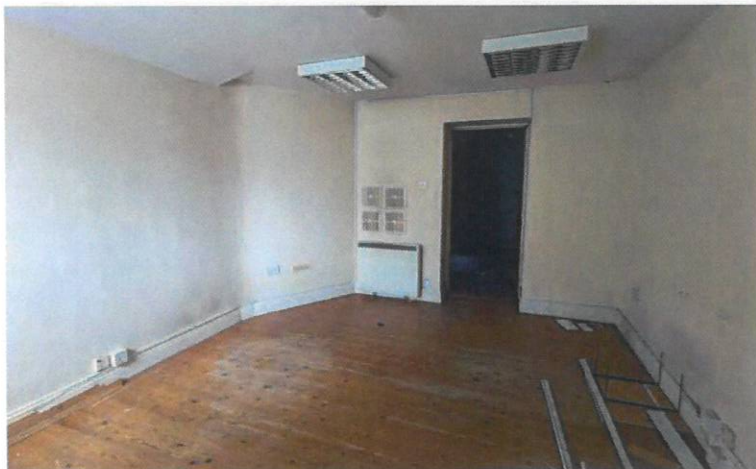
Room G02 looking north

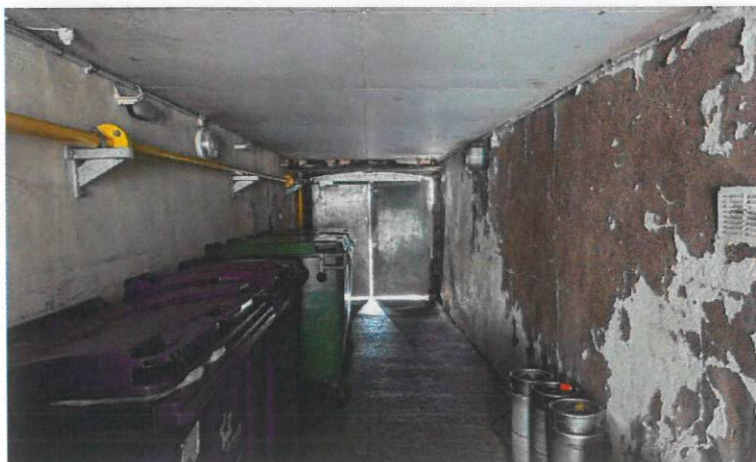
Passageway G02 looking south.

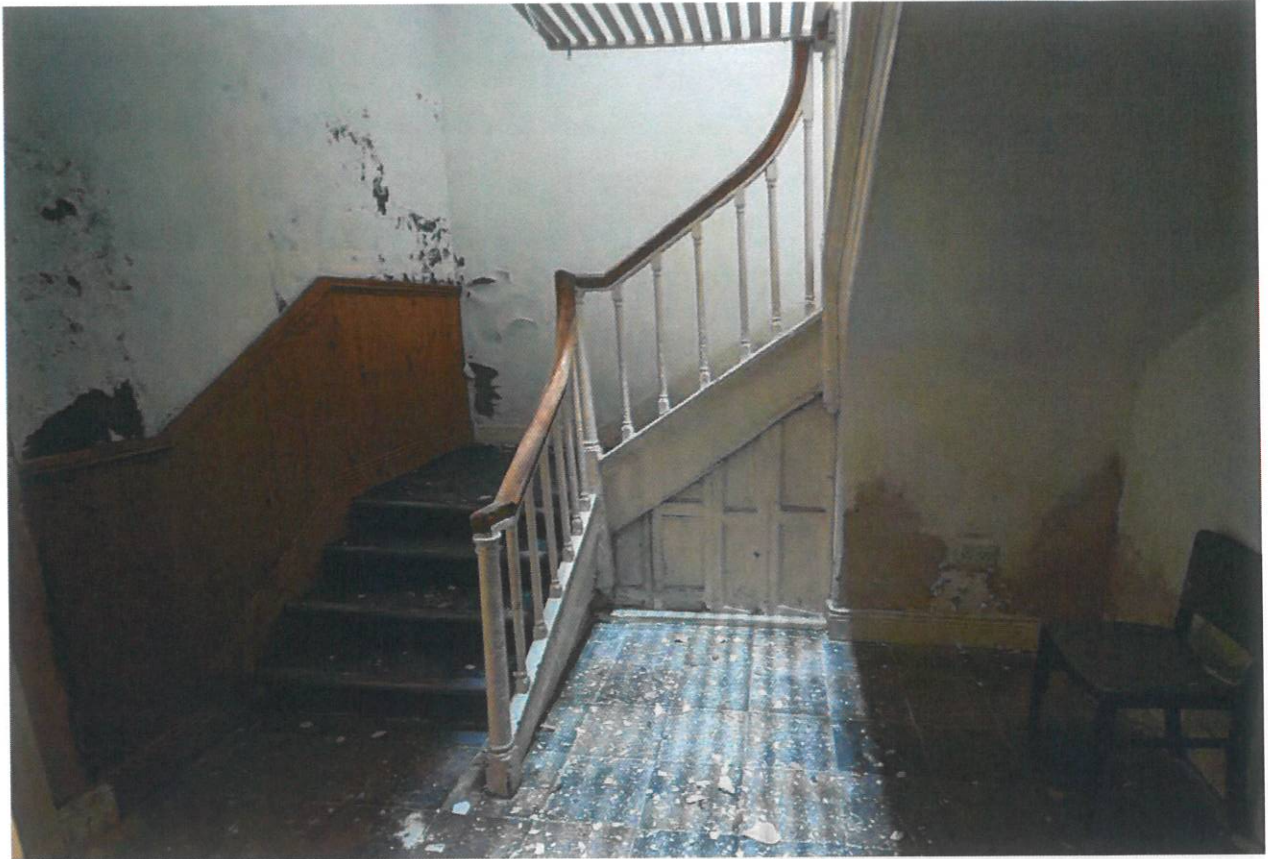
Stairwell G03 looking south west.

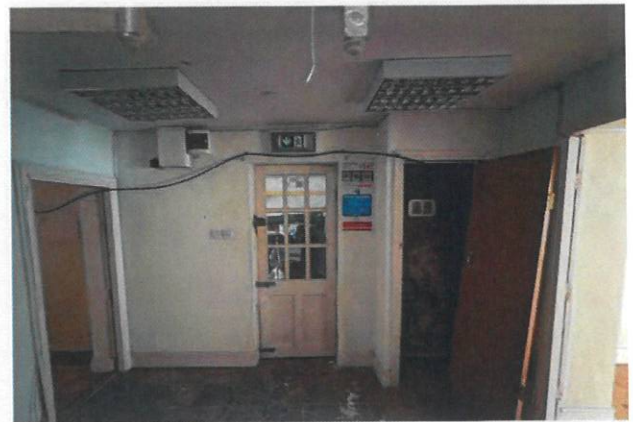
Room G03 looking east.

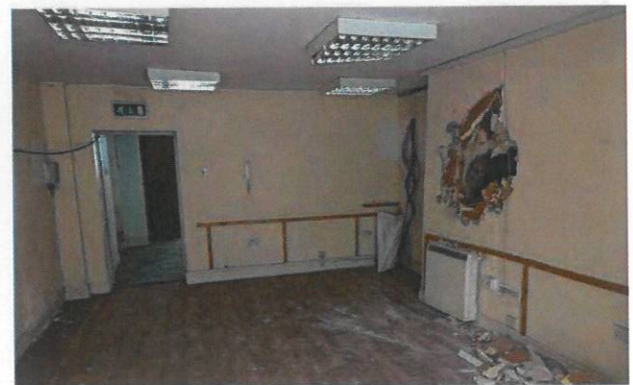
Room G04 looking south.

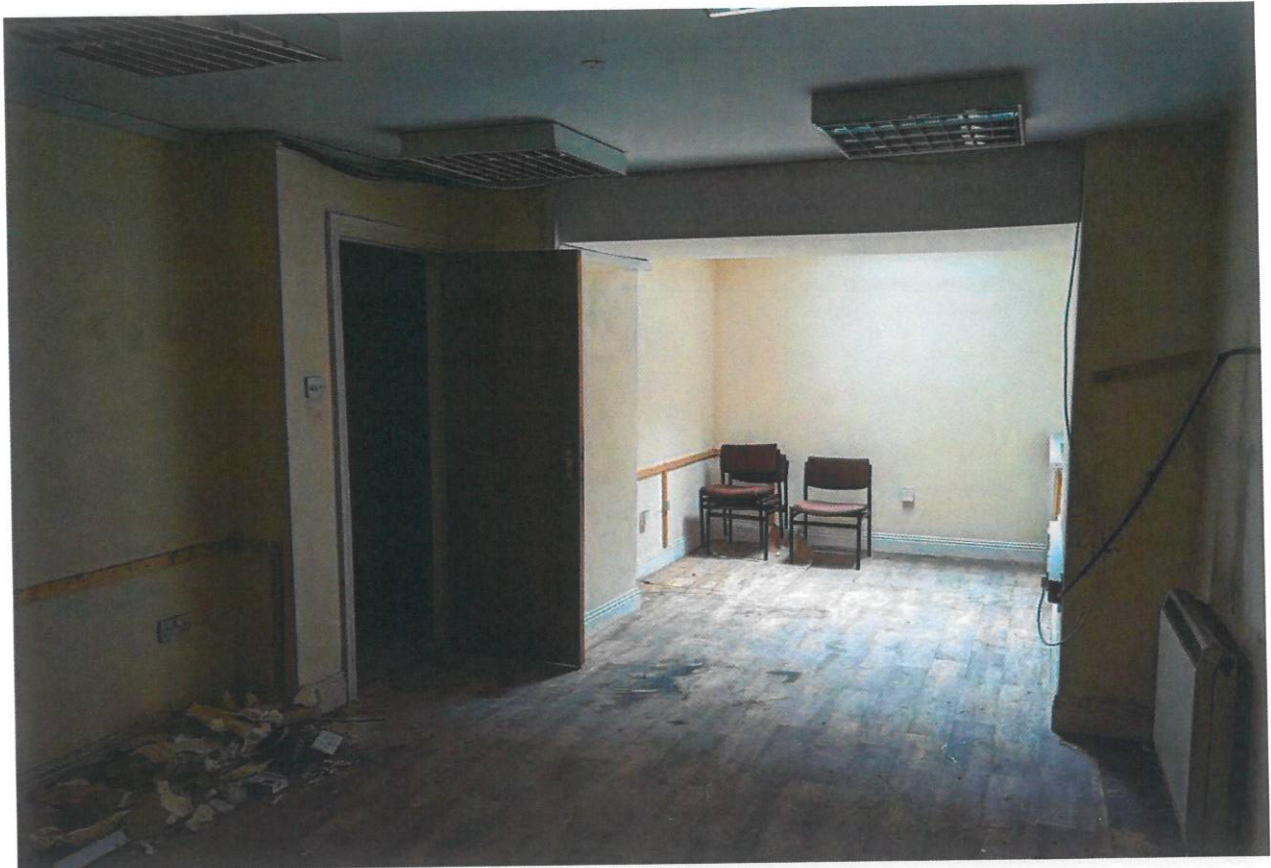
Room G04 looking north.

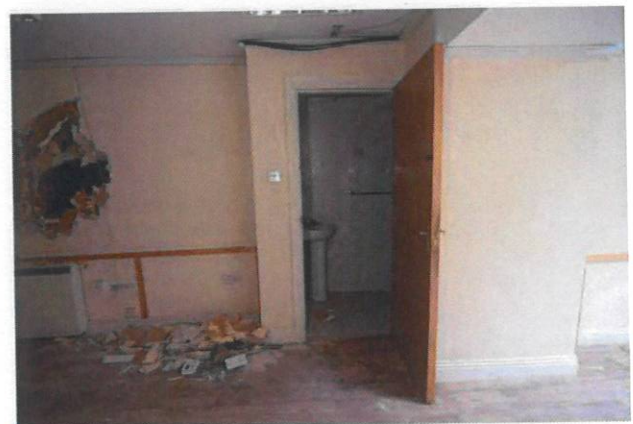
Room G04 looking west showing door to G05.

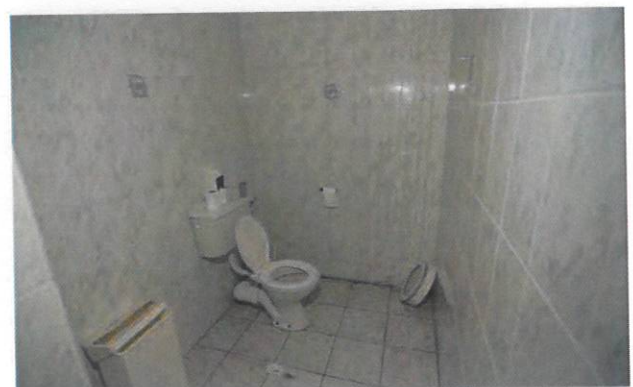
Room G05 looking north.

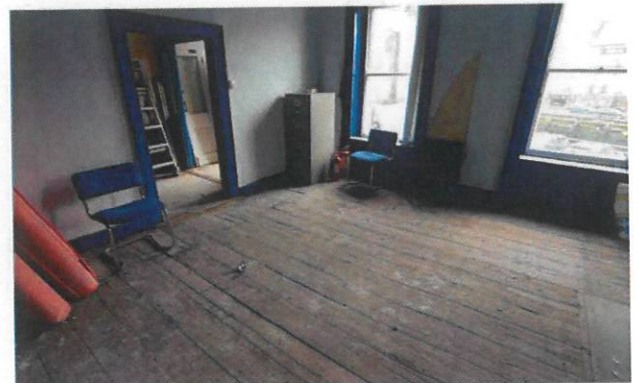
Room F01 looking southeast.

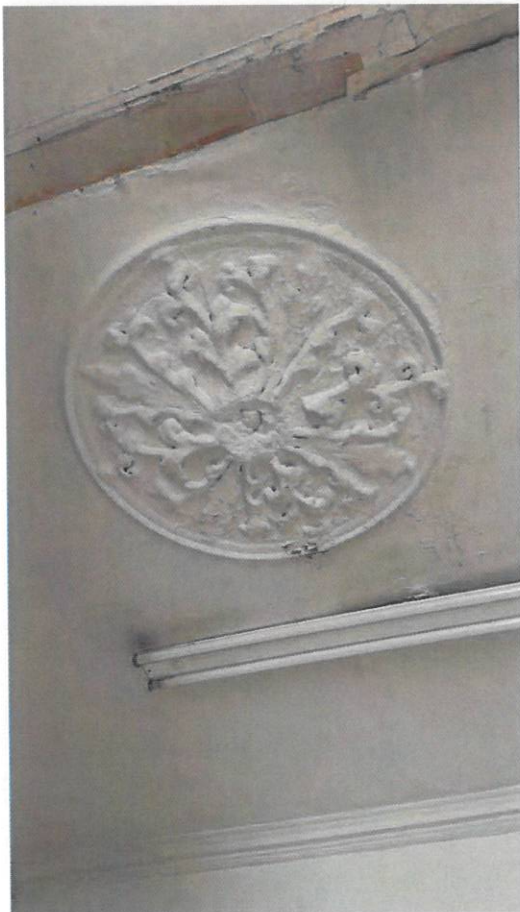
Ceiling rose and cornice detail.

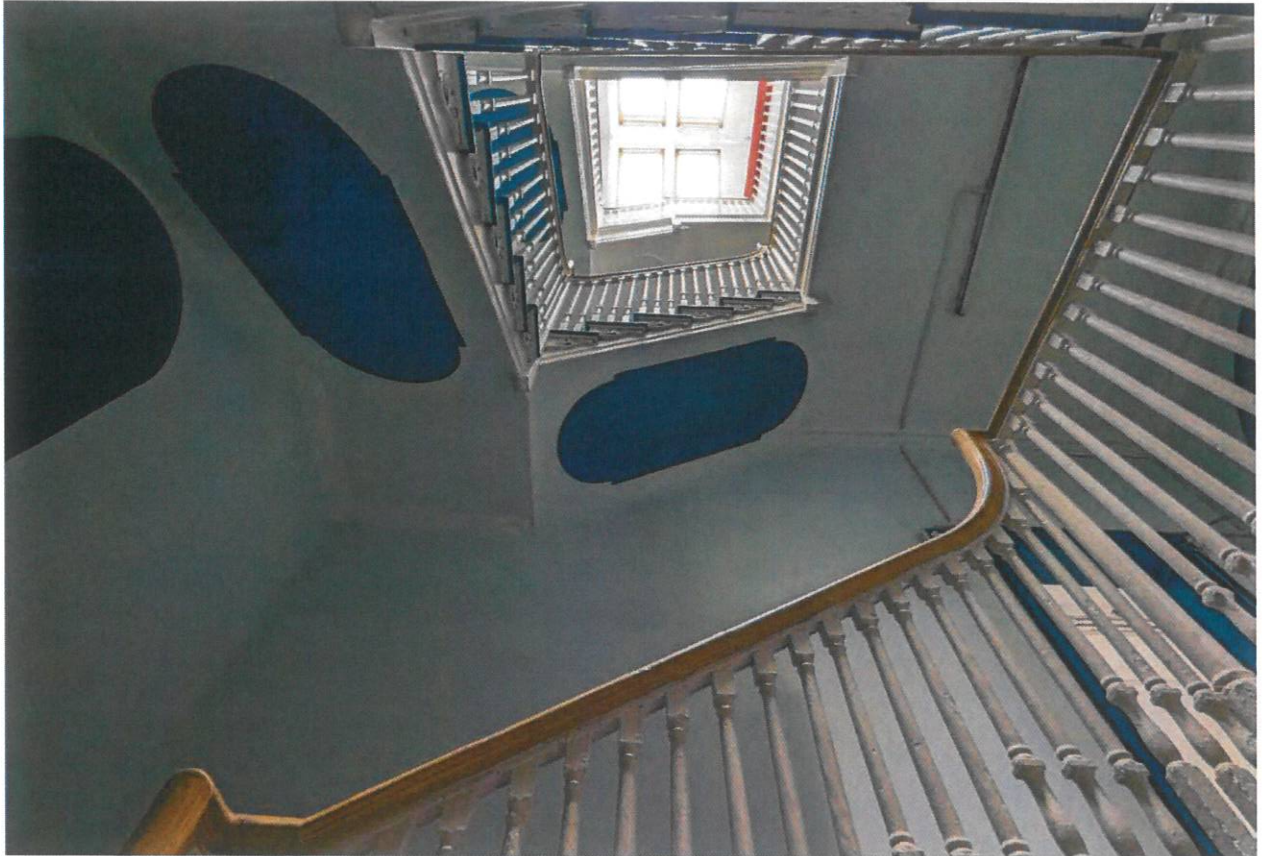
Stairwell looking up from F02.

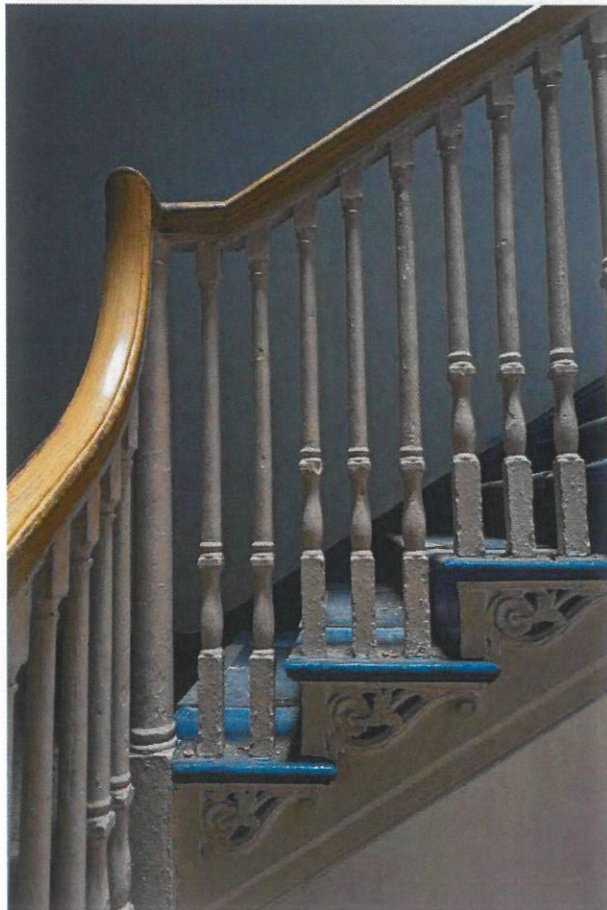
Detail of stairs.

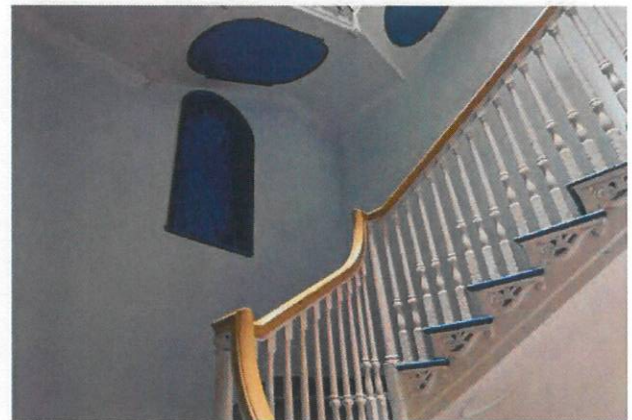
Niche to stairs between 1st and 2nd floor.

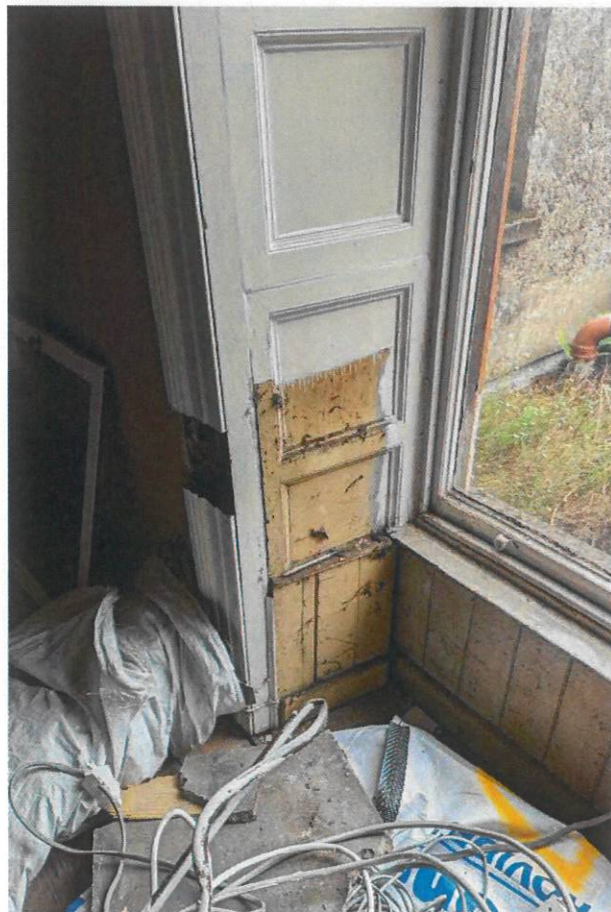
Window, reveal and architrave.

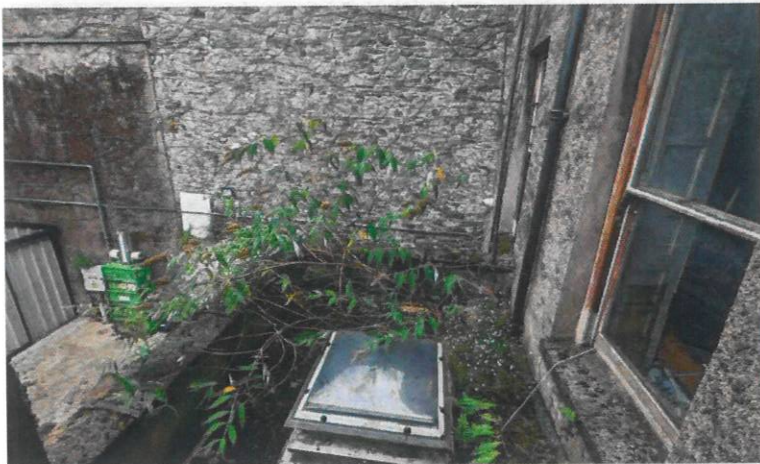
View from F04 over roof of G04 and windows to F03.

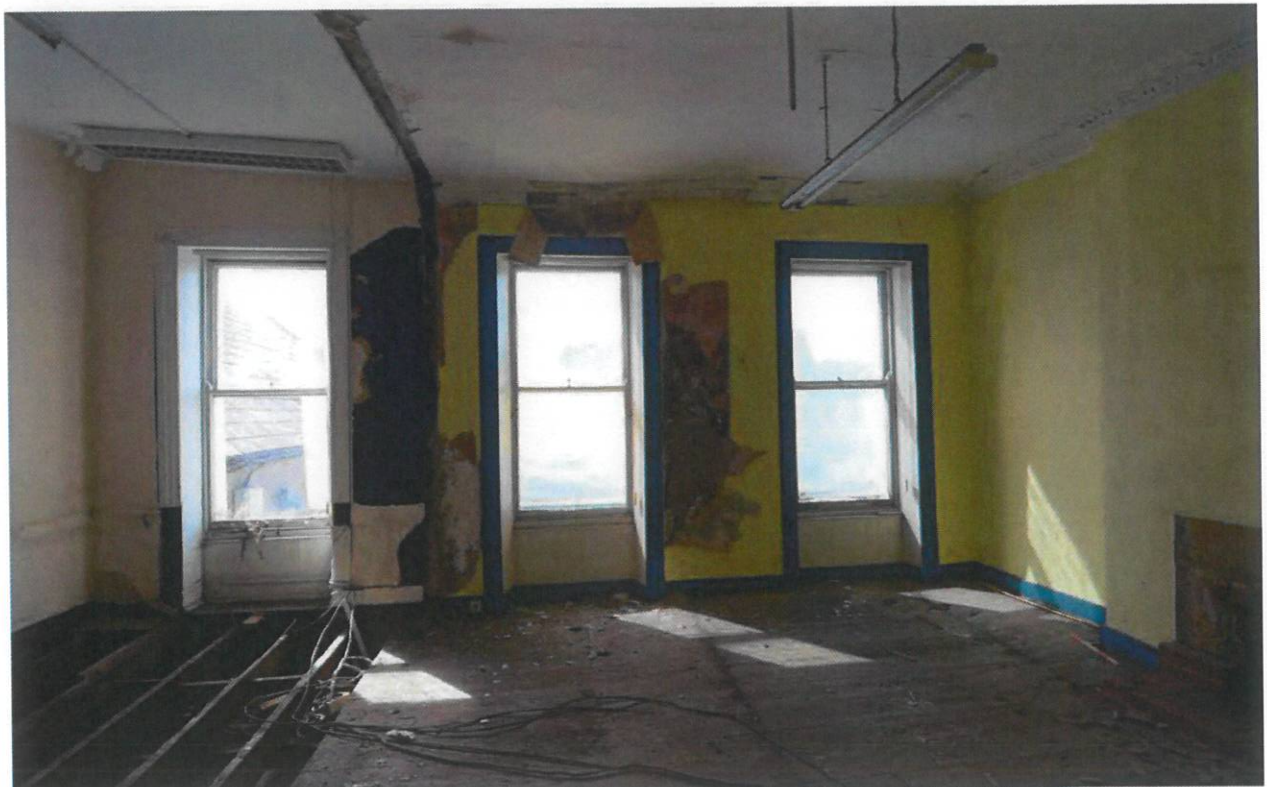
Room S01 looking south.

Rectangular plan room, lit by three windows in south wall and accessed via a door from the landing in S02 to the north. Fireplace in square profile projecting chimneybreast to west wall, having partial fire surround, formed of late twentieth century brick and no mantel. Removed floor boards reveal a mix of adze dressed and sawn joist timbers and plasterboard ceiling beneath. Timber boarded floors (partially removed), plastered walls and ceilings, moulded architrave. Timber skirting boards (partially removed). Moulded timber architraves to windows having plain timber reveals with timber batten to riser area. Scar to wall and loss of ceiling architrave in eastern portion of room where a stud partition wall was inserted in the past (now removed). Timber moulded architraves to door openings. Fire surround, formed of late twentieth century brick, has been partially removed and no mantel remains.

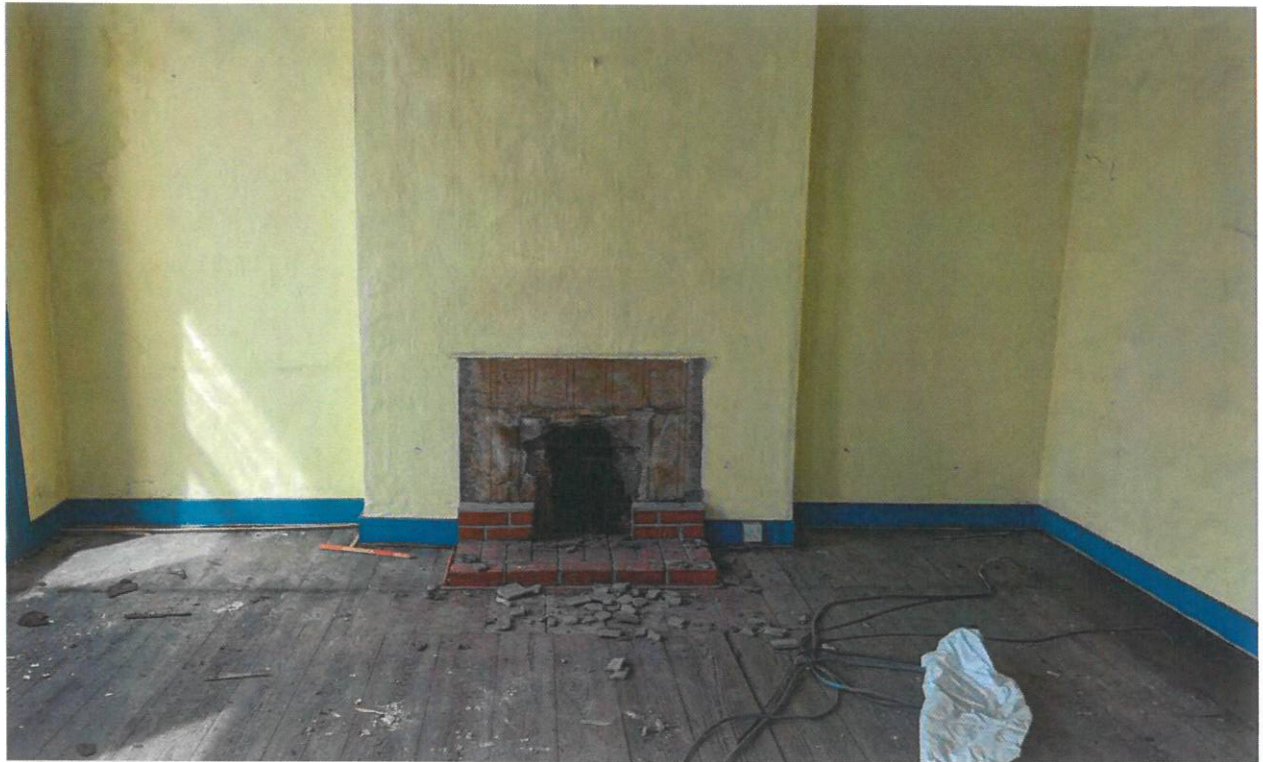
Room S01 looking west.

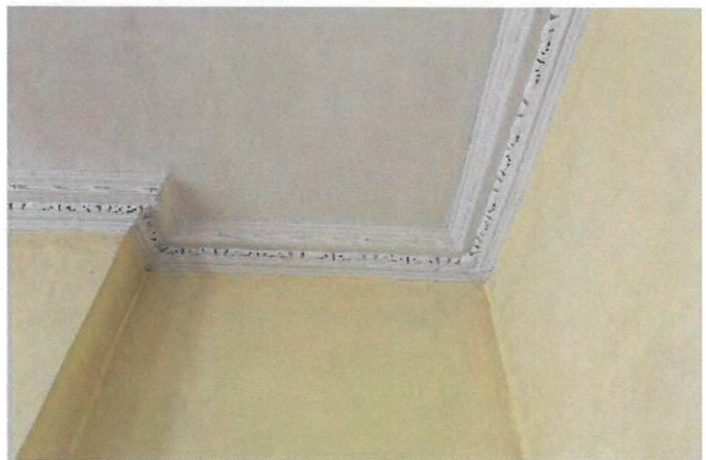
Plasterwork to room S01.

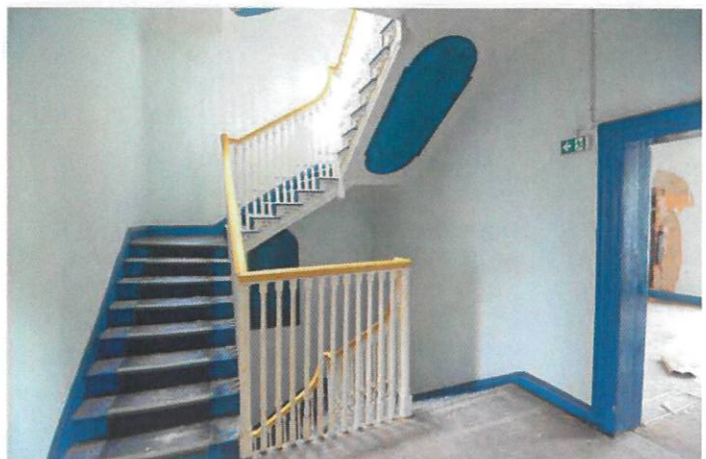
S02 looking west.

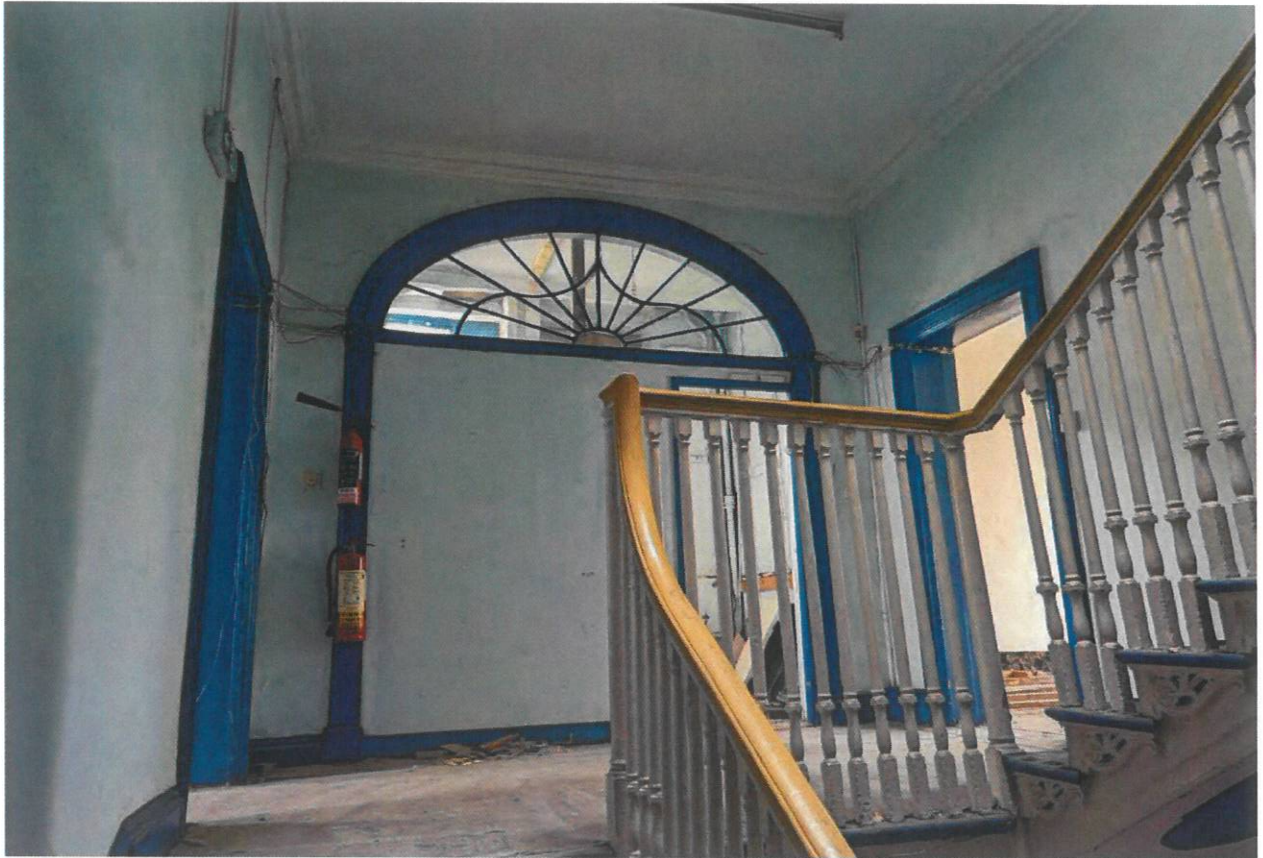
Stairwell S02 looking east.

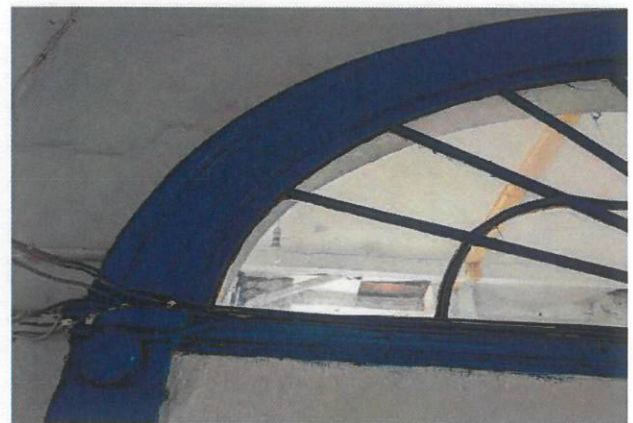
Detail of fanlight glazing.

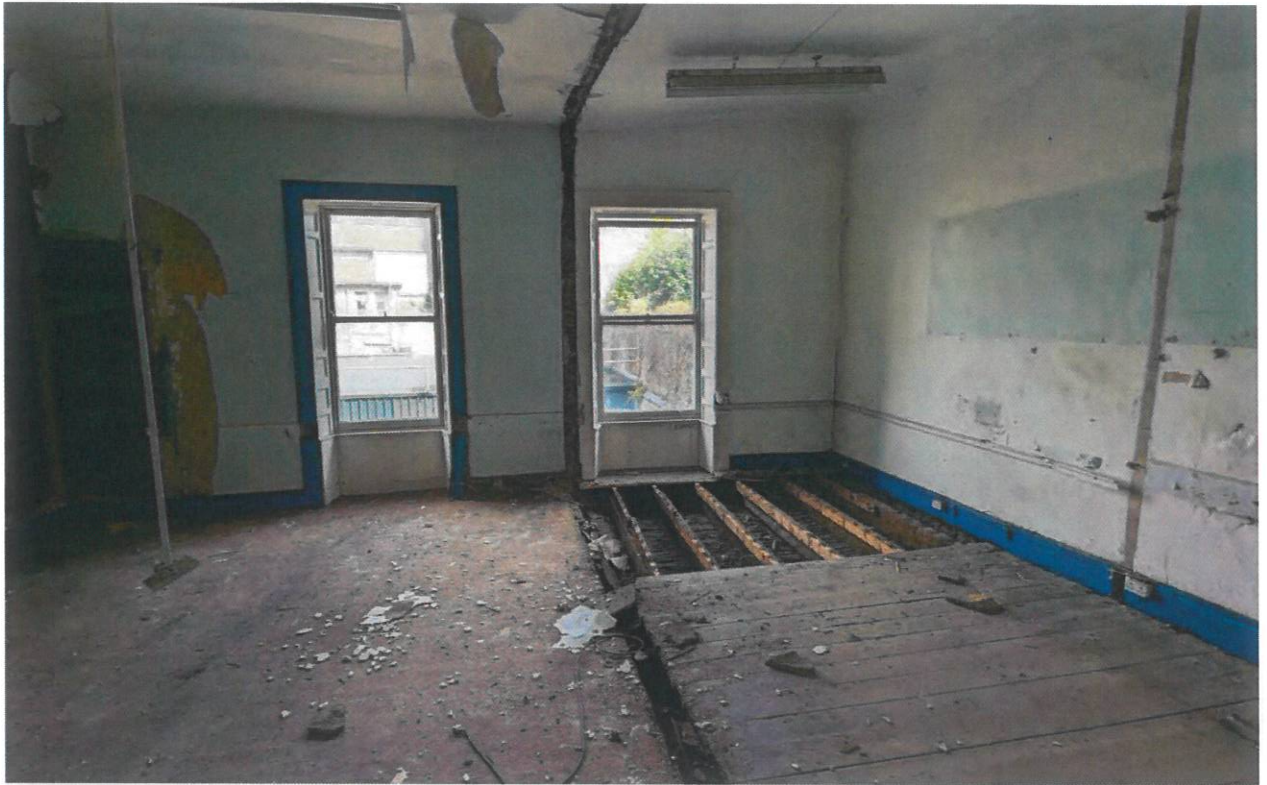
Room S04 looking north.

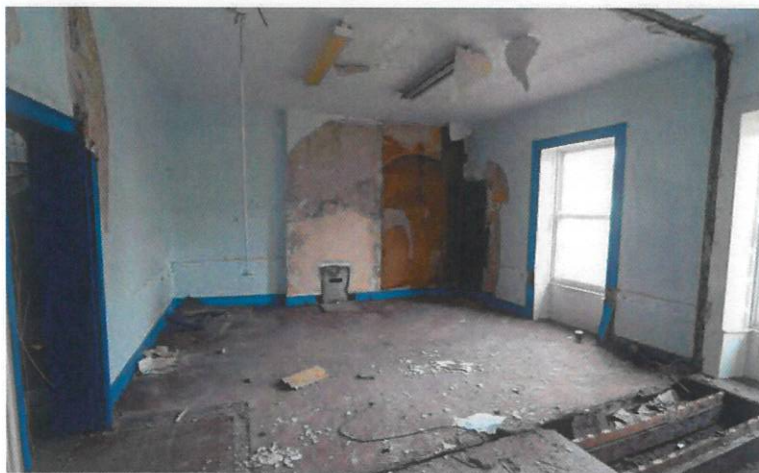
Room S04 looking northwest

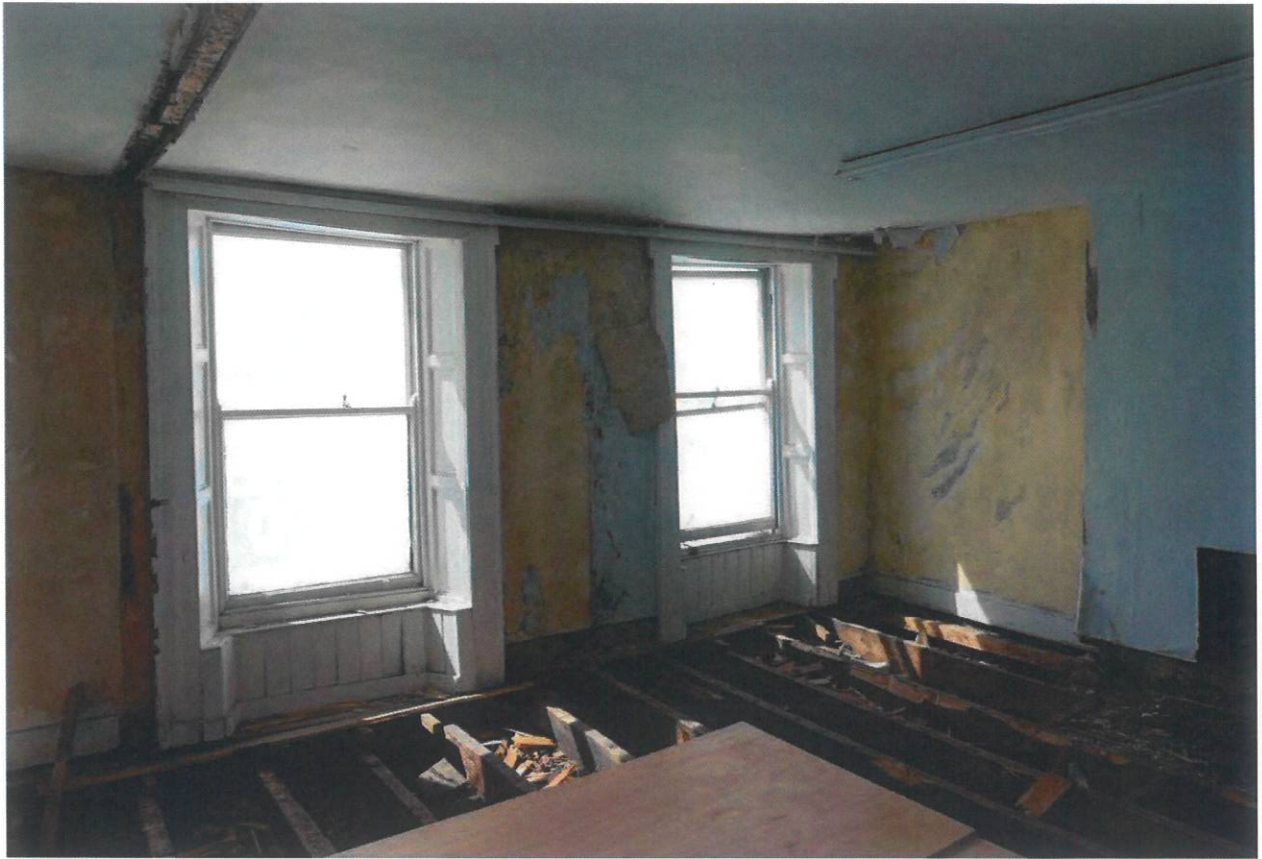
Room T01 looking southwest.

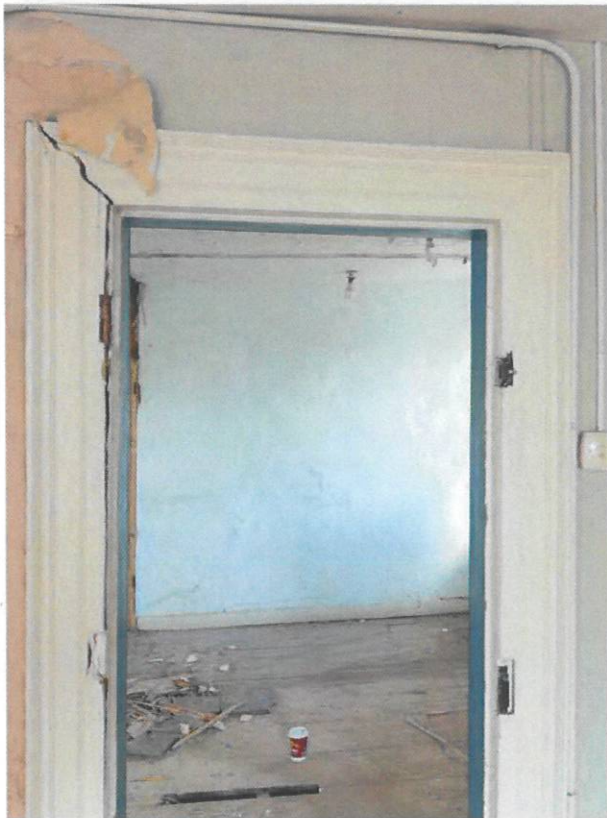
Detail of door architrave in T01.

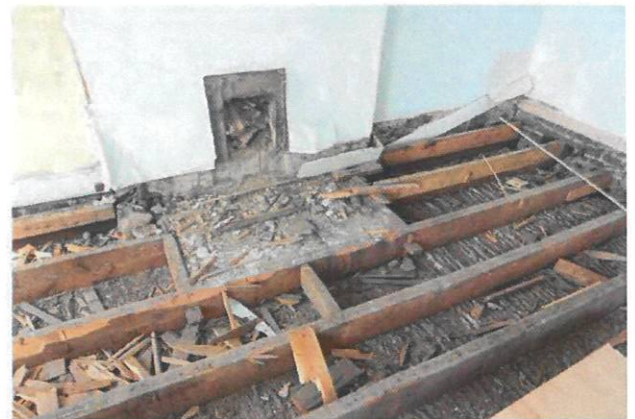
Fireplace and floor in T01.

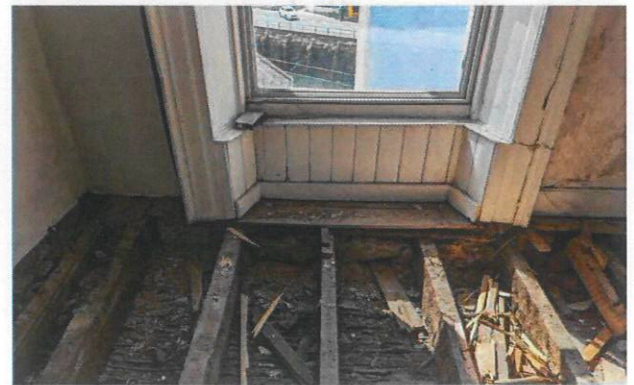
Window reveal and cill in T01.

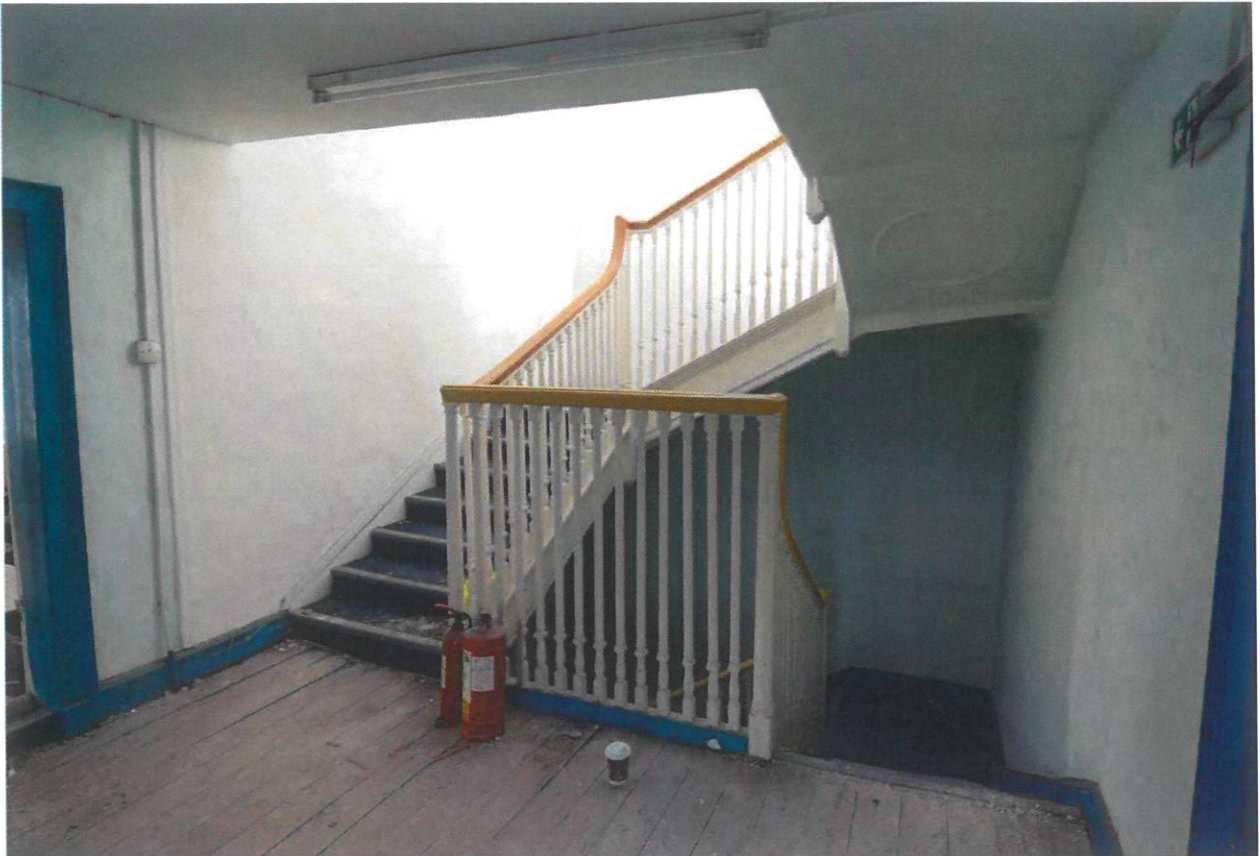
Room T02 looking towards stairs.

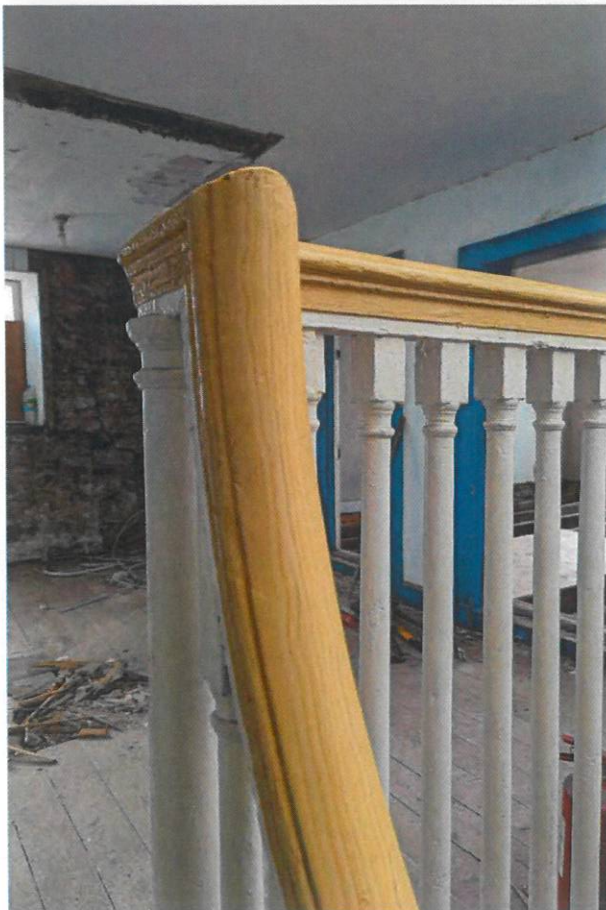
Detail of stair balustrade in T02.

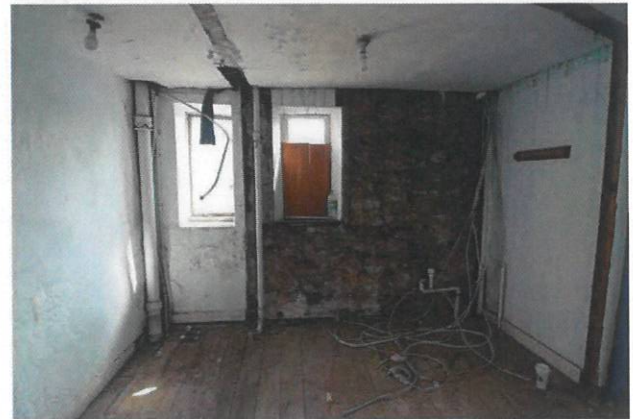
Room T02 looking east.

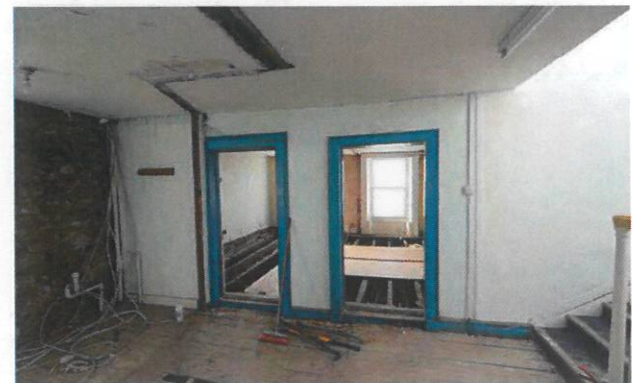
Room T02 showing twin doors to S01 at south.

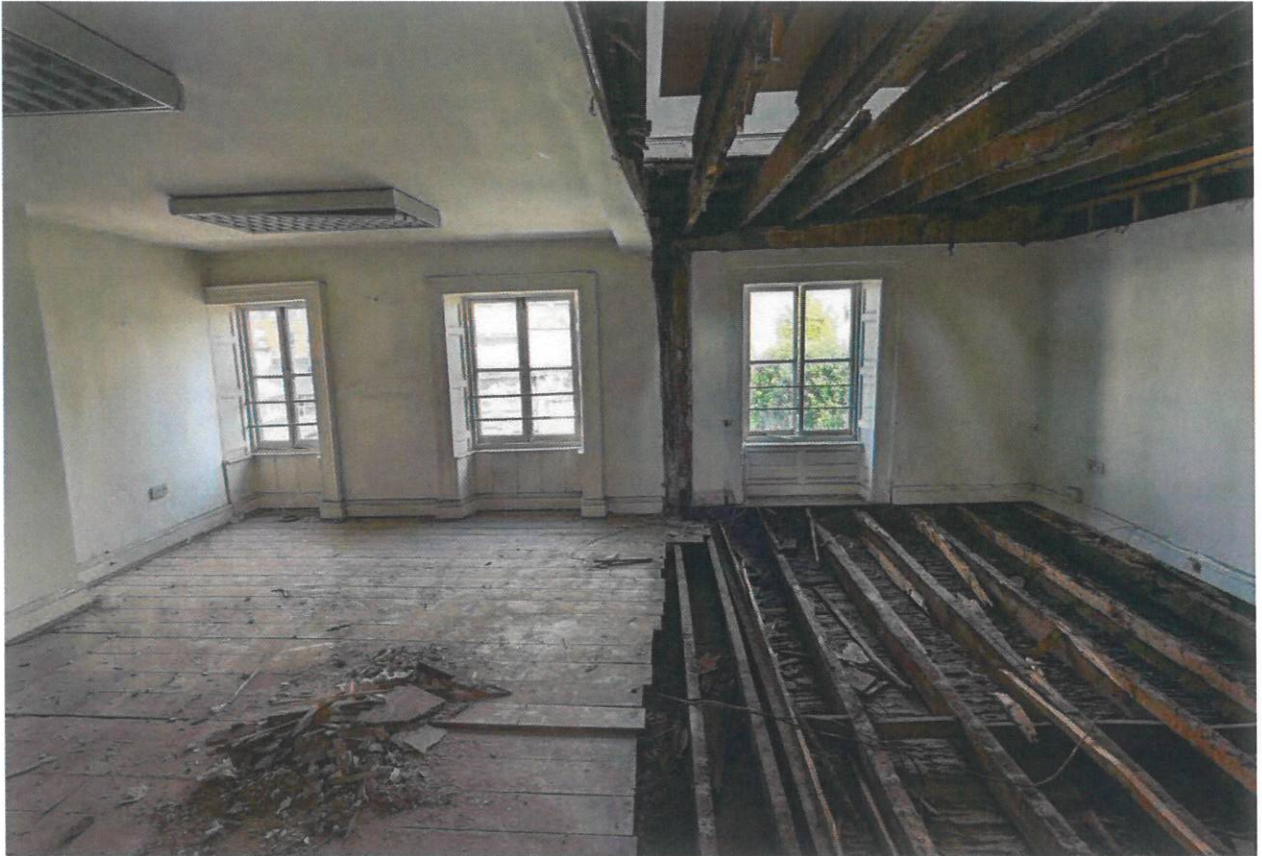
Room T03 looking north.

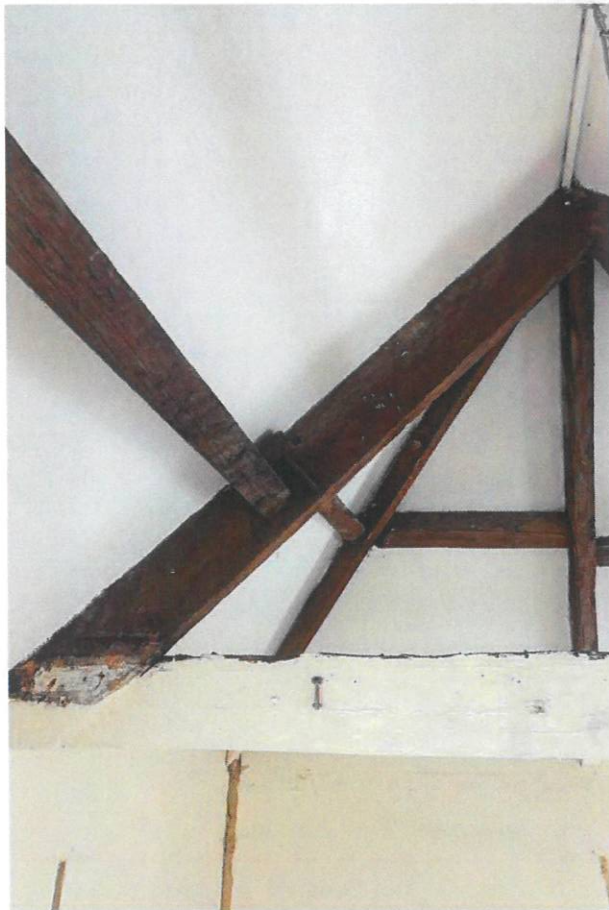
Exposed roof timbers in C01.

- It is proposed to retain/repair in-situ existing building fabric, timber floors, ceilings, stone boundary wall, historic pedestrian entrances.
- Existing roof timbers including all primary members will be retained and repaired where possible, to include the splicing of structural timbers.

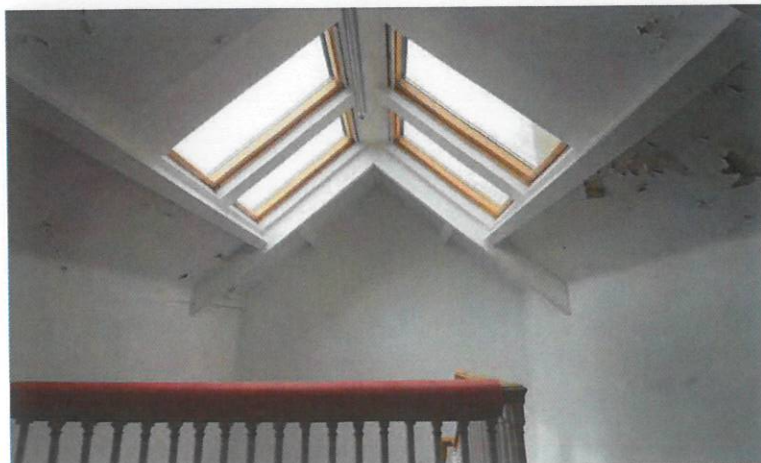
Rooflights in C02
