Heritage Impact Assessment

No 7 Father Mathew Quay

Cork City Record of Protected Structures – PS085

Report By: Robin Turk & Daniel Noonan

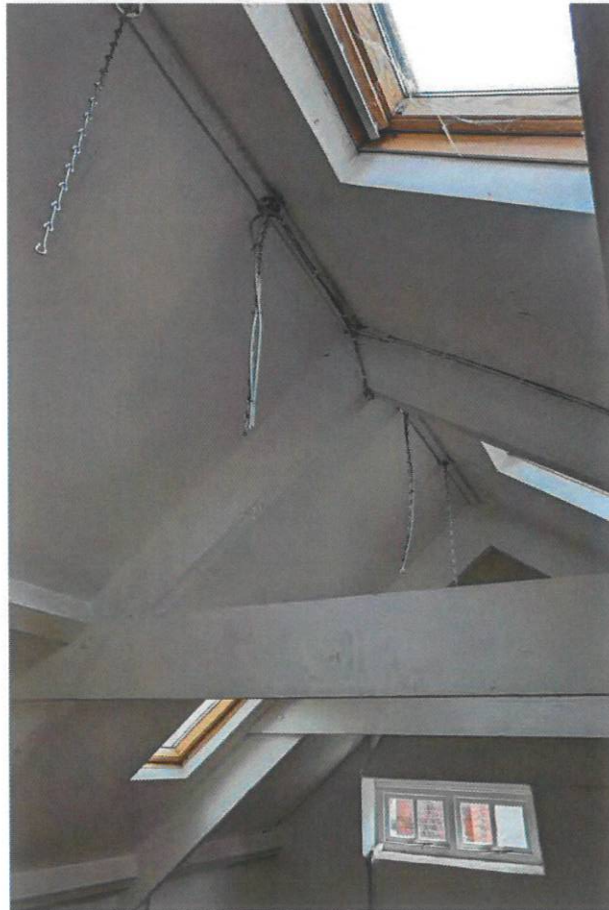
Exposed roof timbers in C03.

- It is proposed to retain/repair in-situ existing building fabric, timber floors, ceilings, stone boundary wall, historic pedestrian entrances.
- Existing roof timbers including all primary members will be retained and repaired where possible, to include the splicing of structural timbers.
