Heritage Impact Assessment

No 7 Father Mathew Quay

Cork City Record of Protected Structures – PS085

Report By: Robin Turk & Daniel Noonan

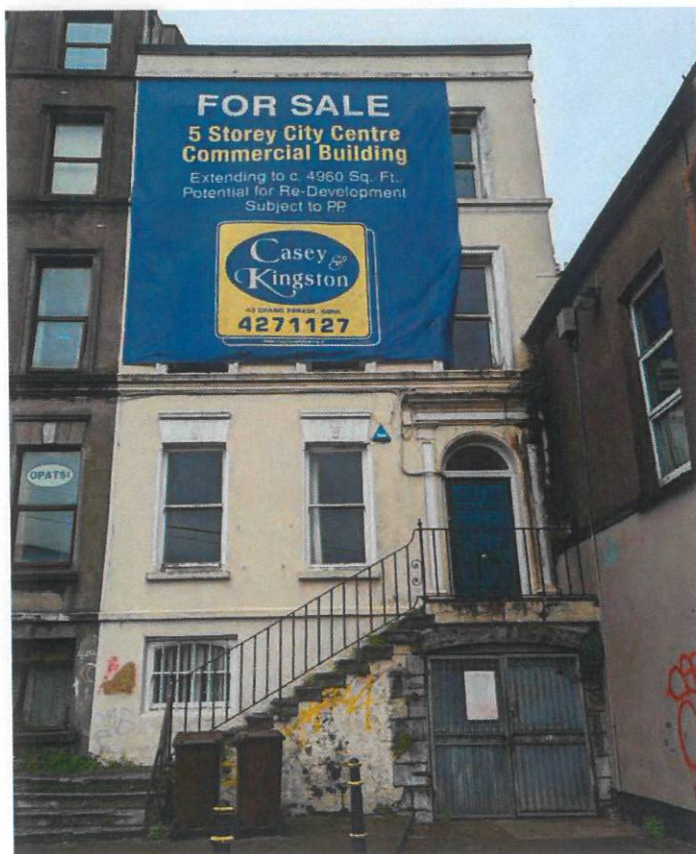
South elevation.

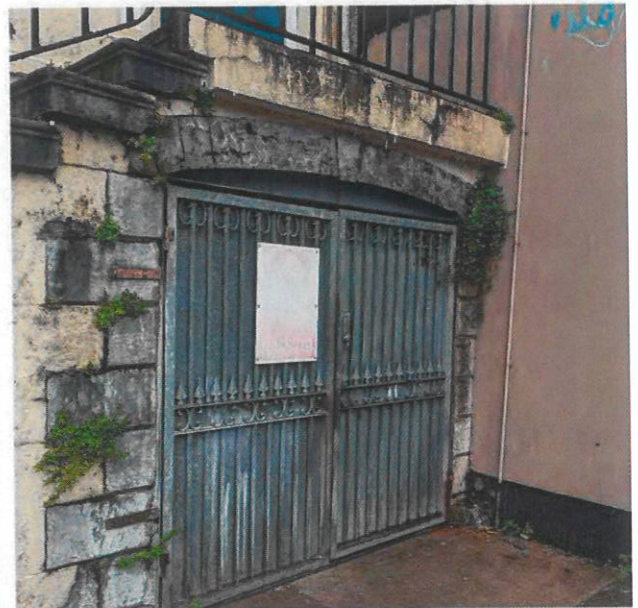
Carriage arch and doors to passage.

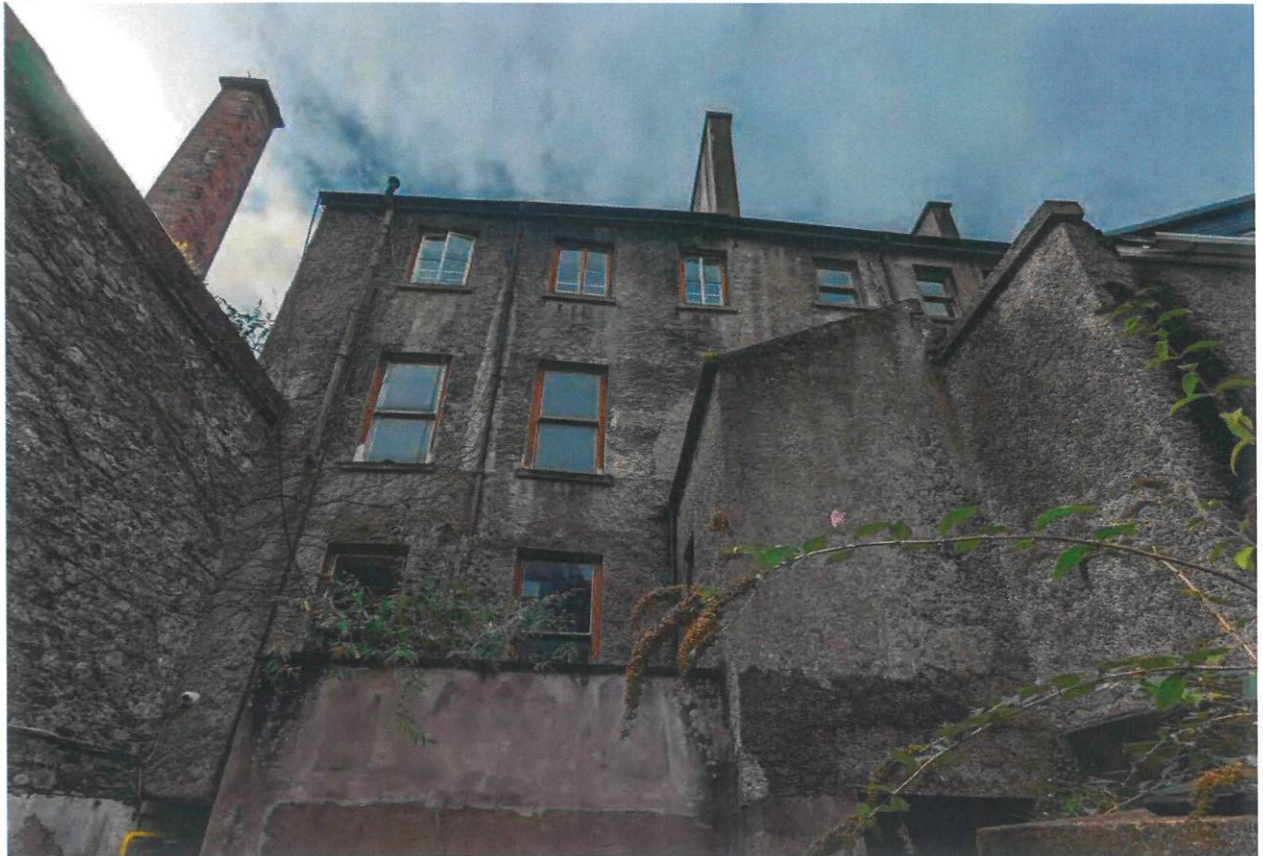
Rear (north) elevation.

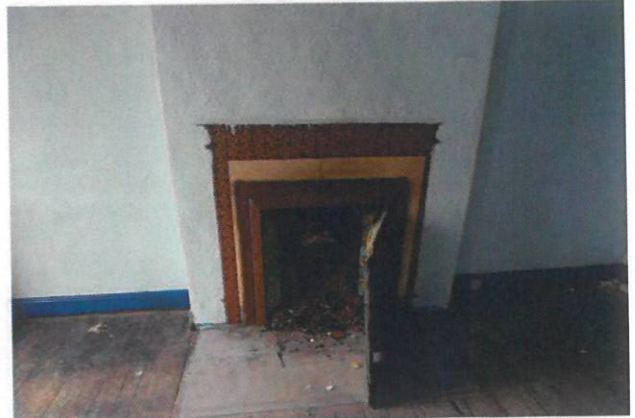
Fireplace in F01.

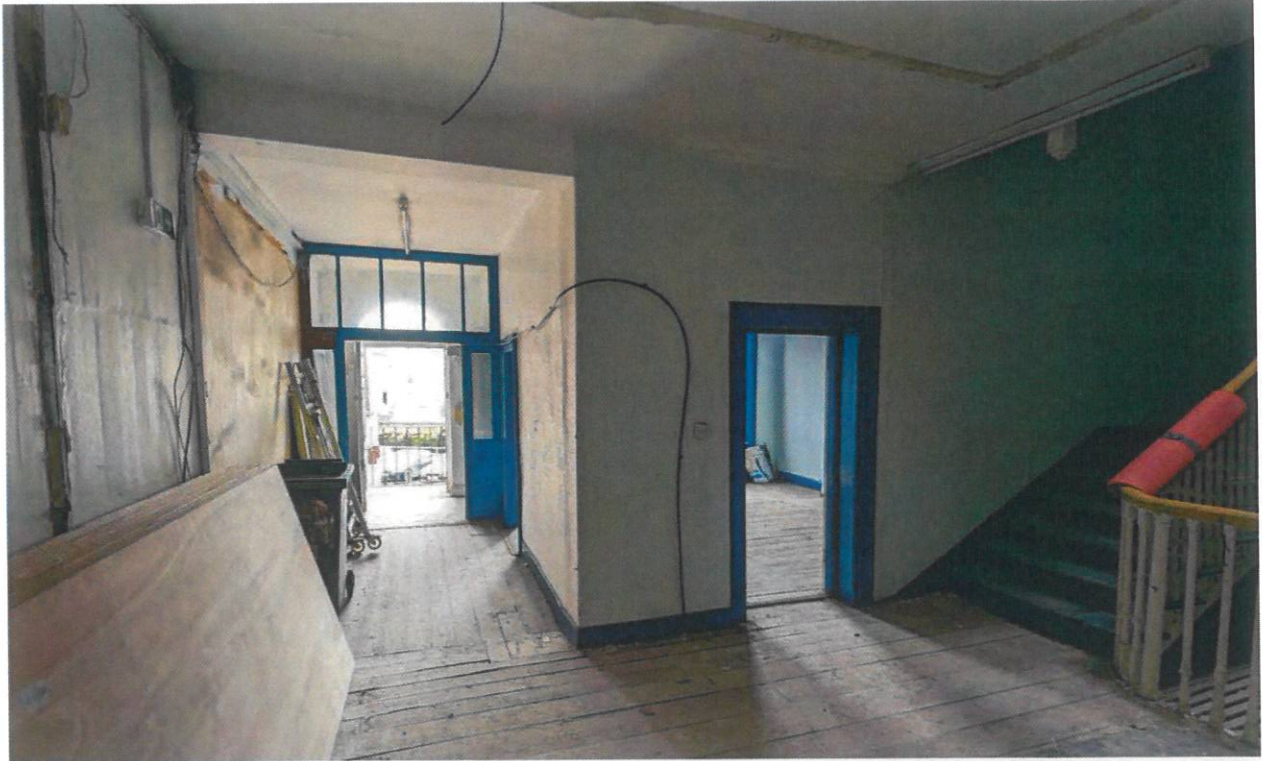
F02 looking south towards front door.

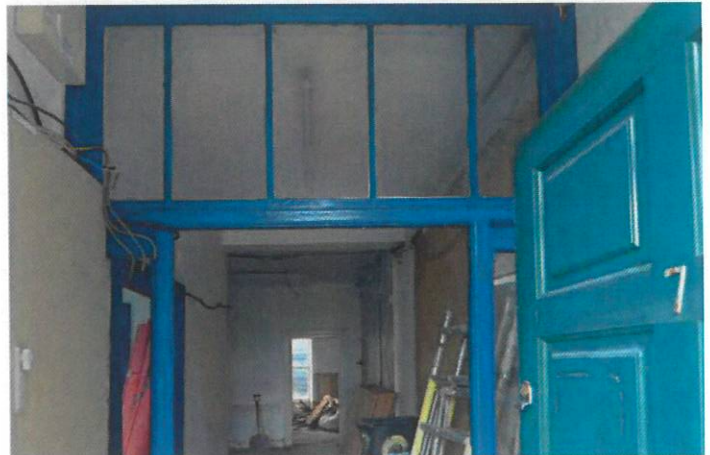
Lobby screen to hall.

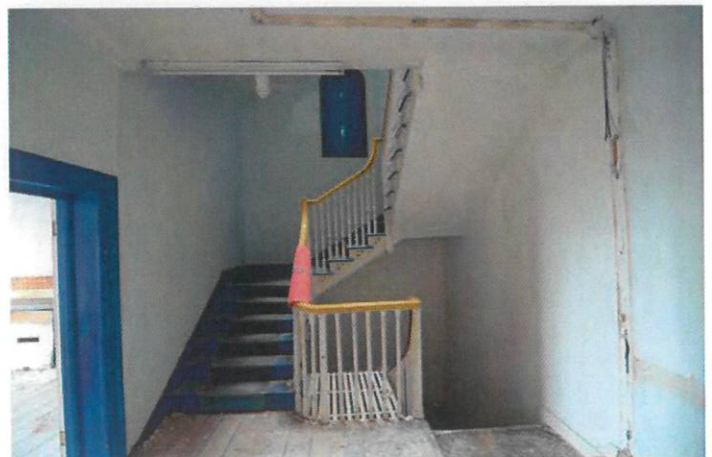
F02 looking west.

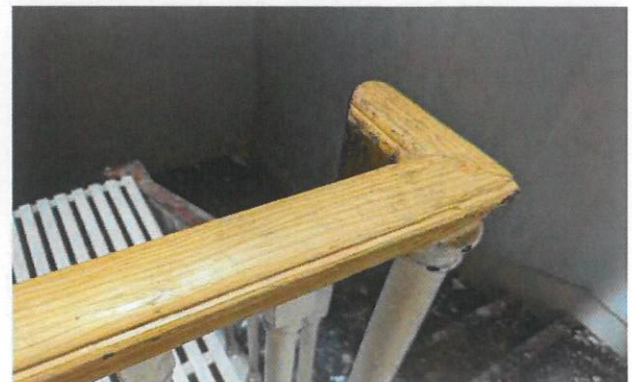
Detail of applied wood grain effect on handrail.

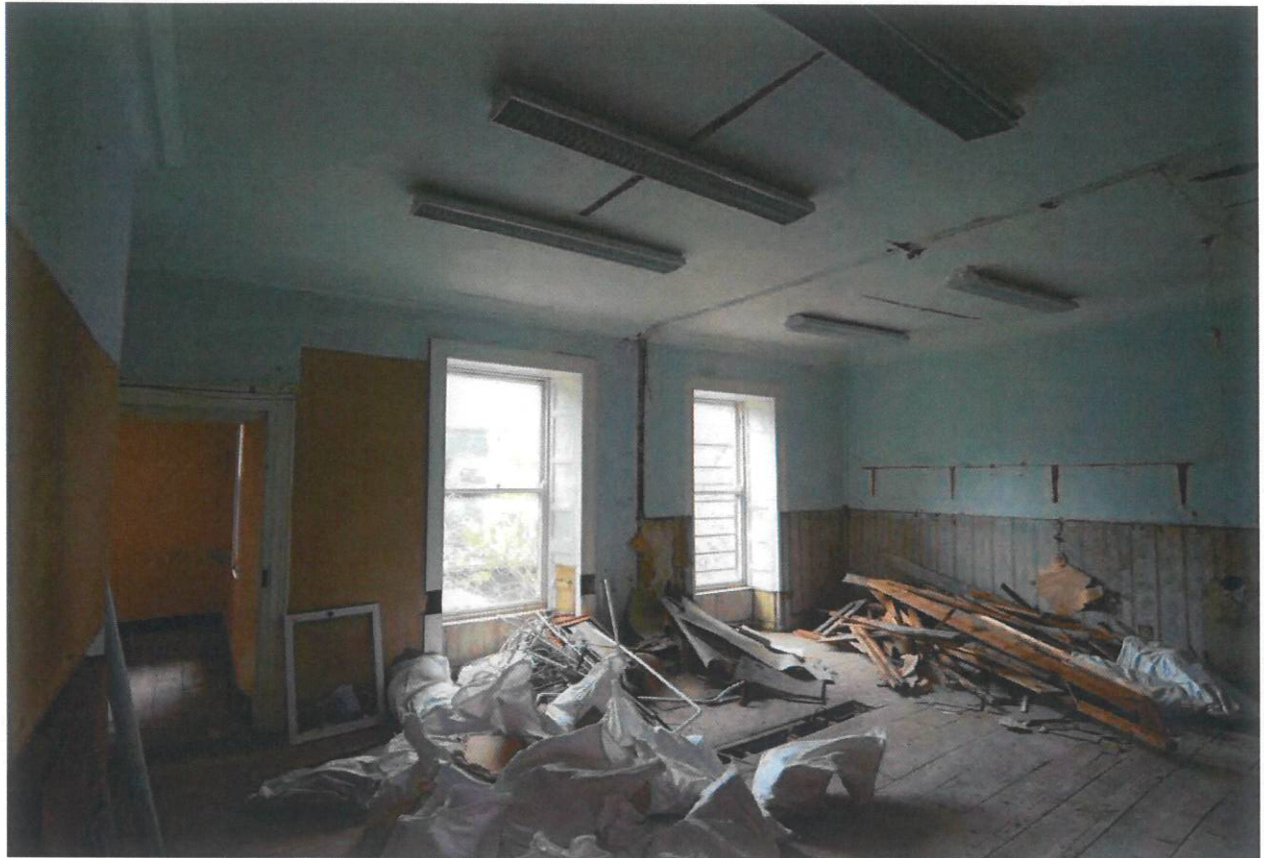
Room F03 looking NE.

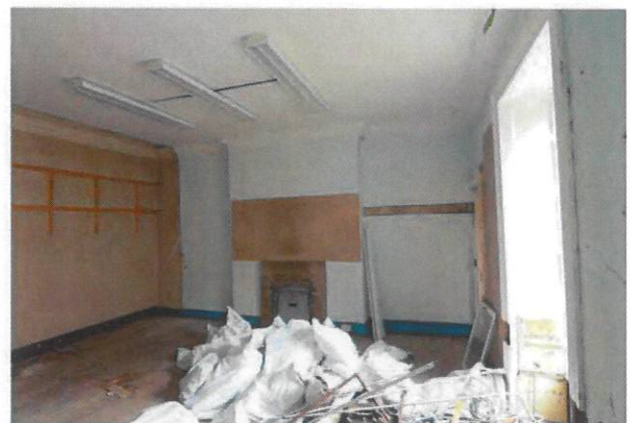
Room F03 looking SW.

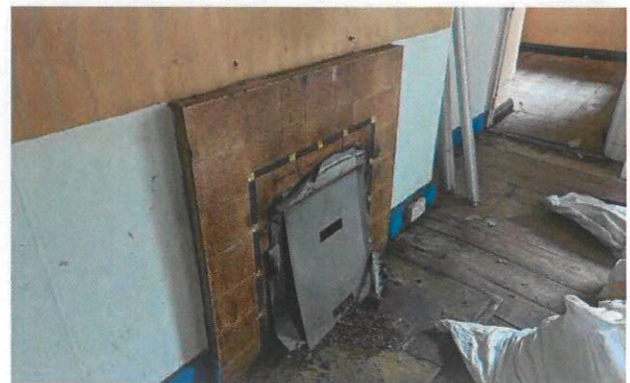
Fireplace in F03.

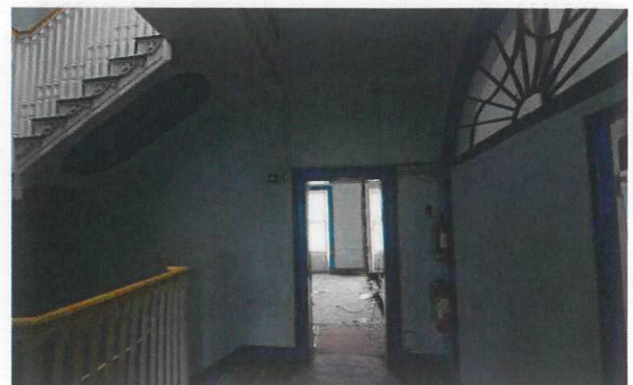
S02 looking north.

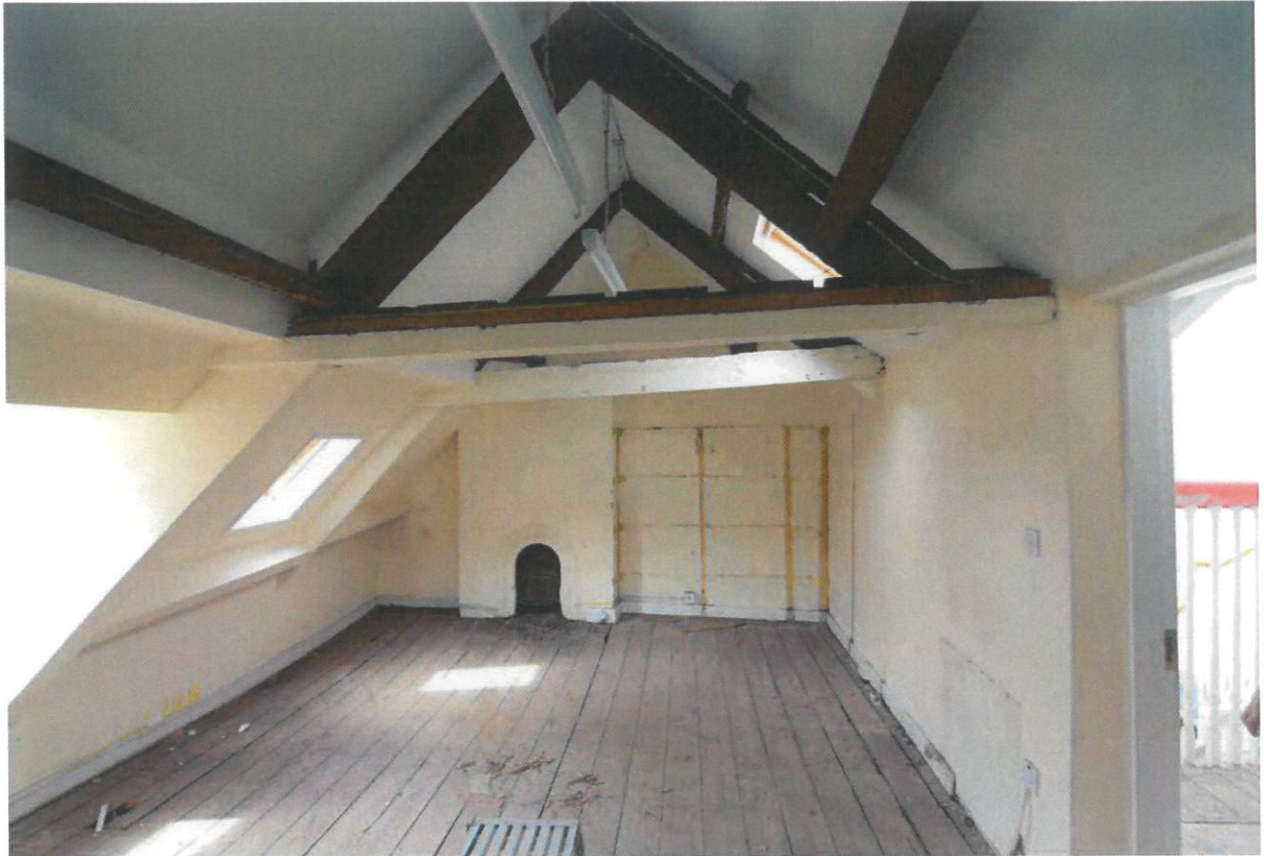
Room C01 looking west.

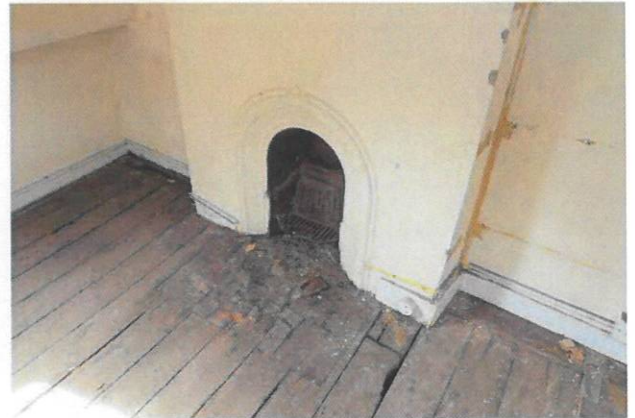
Fireplace to C01.

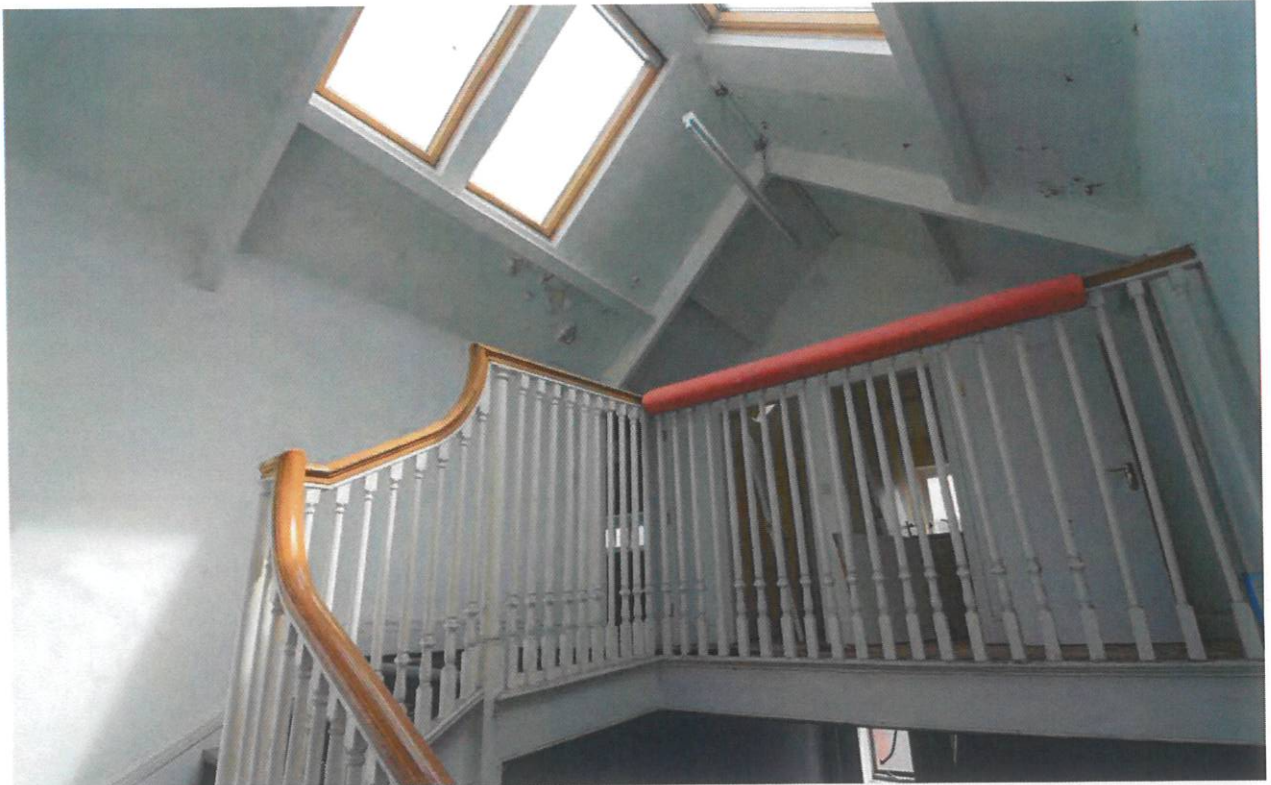
Room C02 looking northeast.

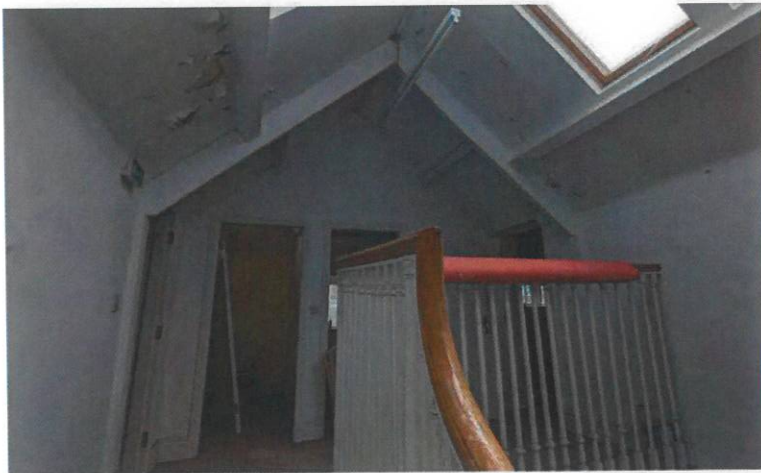
Room C02 looking east

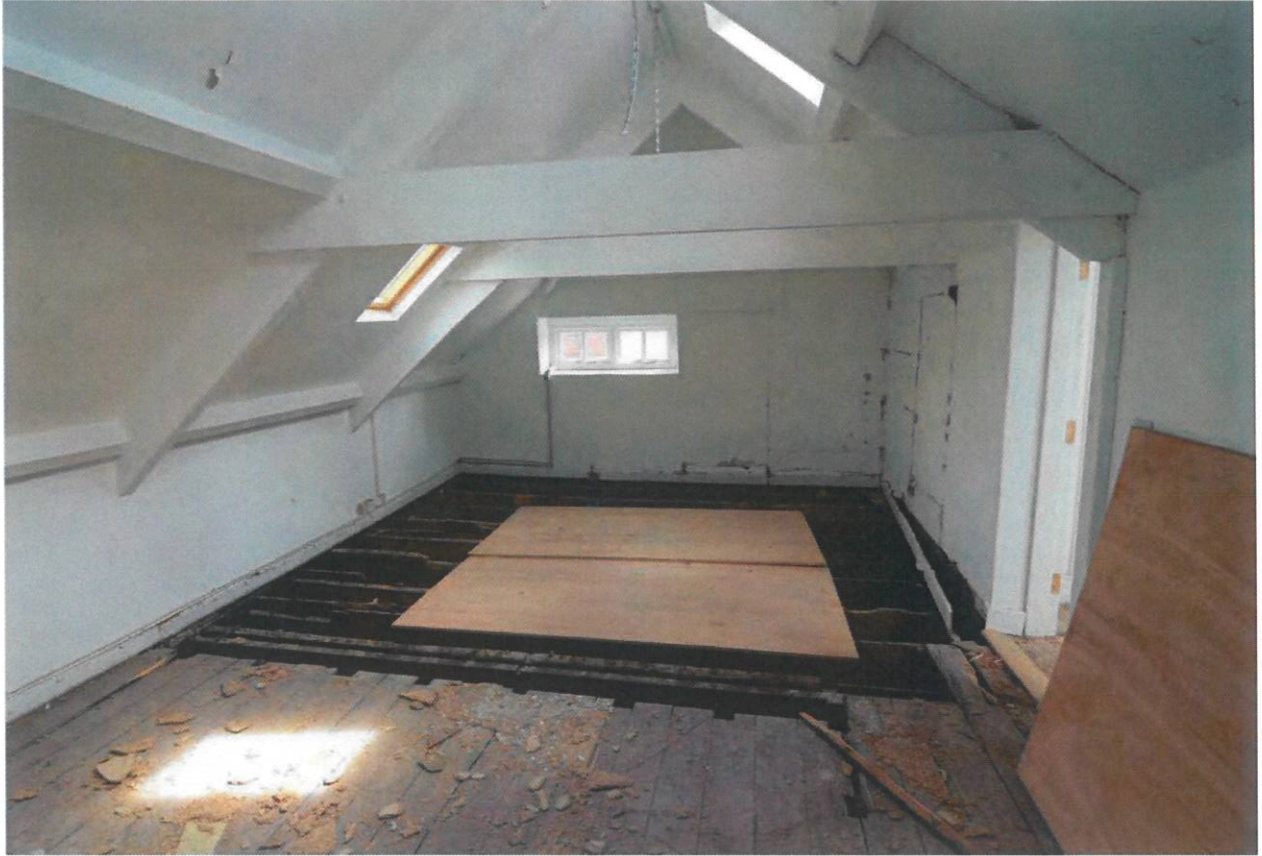
Room C03 looking east.

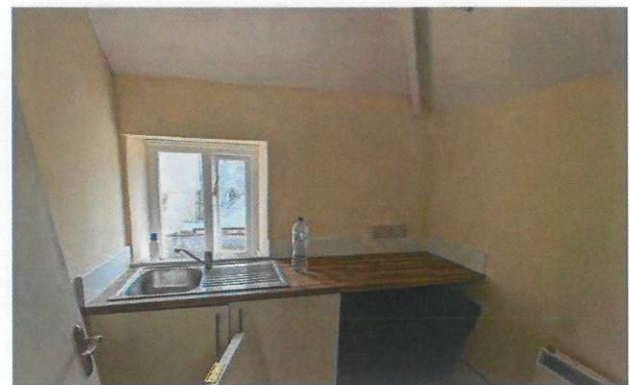
Room C04 looking east.
